COALITION MINING LIMITED
SUKONKA COAL PROJECT
GEOLOGY
VOLUME 1 SUPPLEMENT

SUKUNKA COAL PROJECT

GEOLOGICAL REPORT

1972 SUPPLEMENT

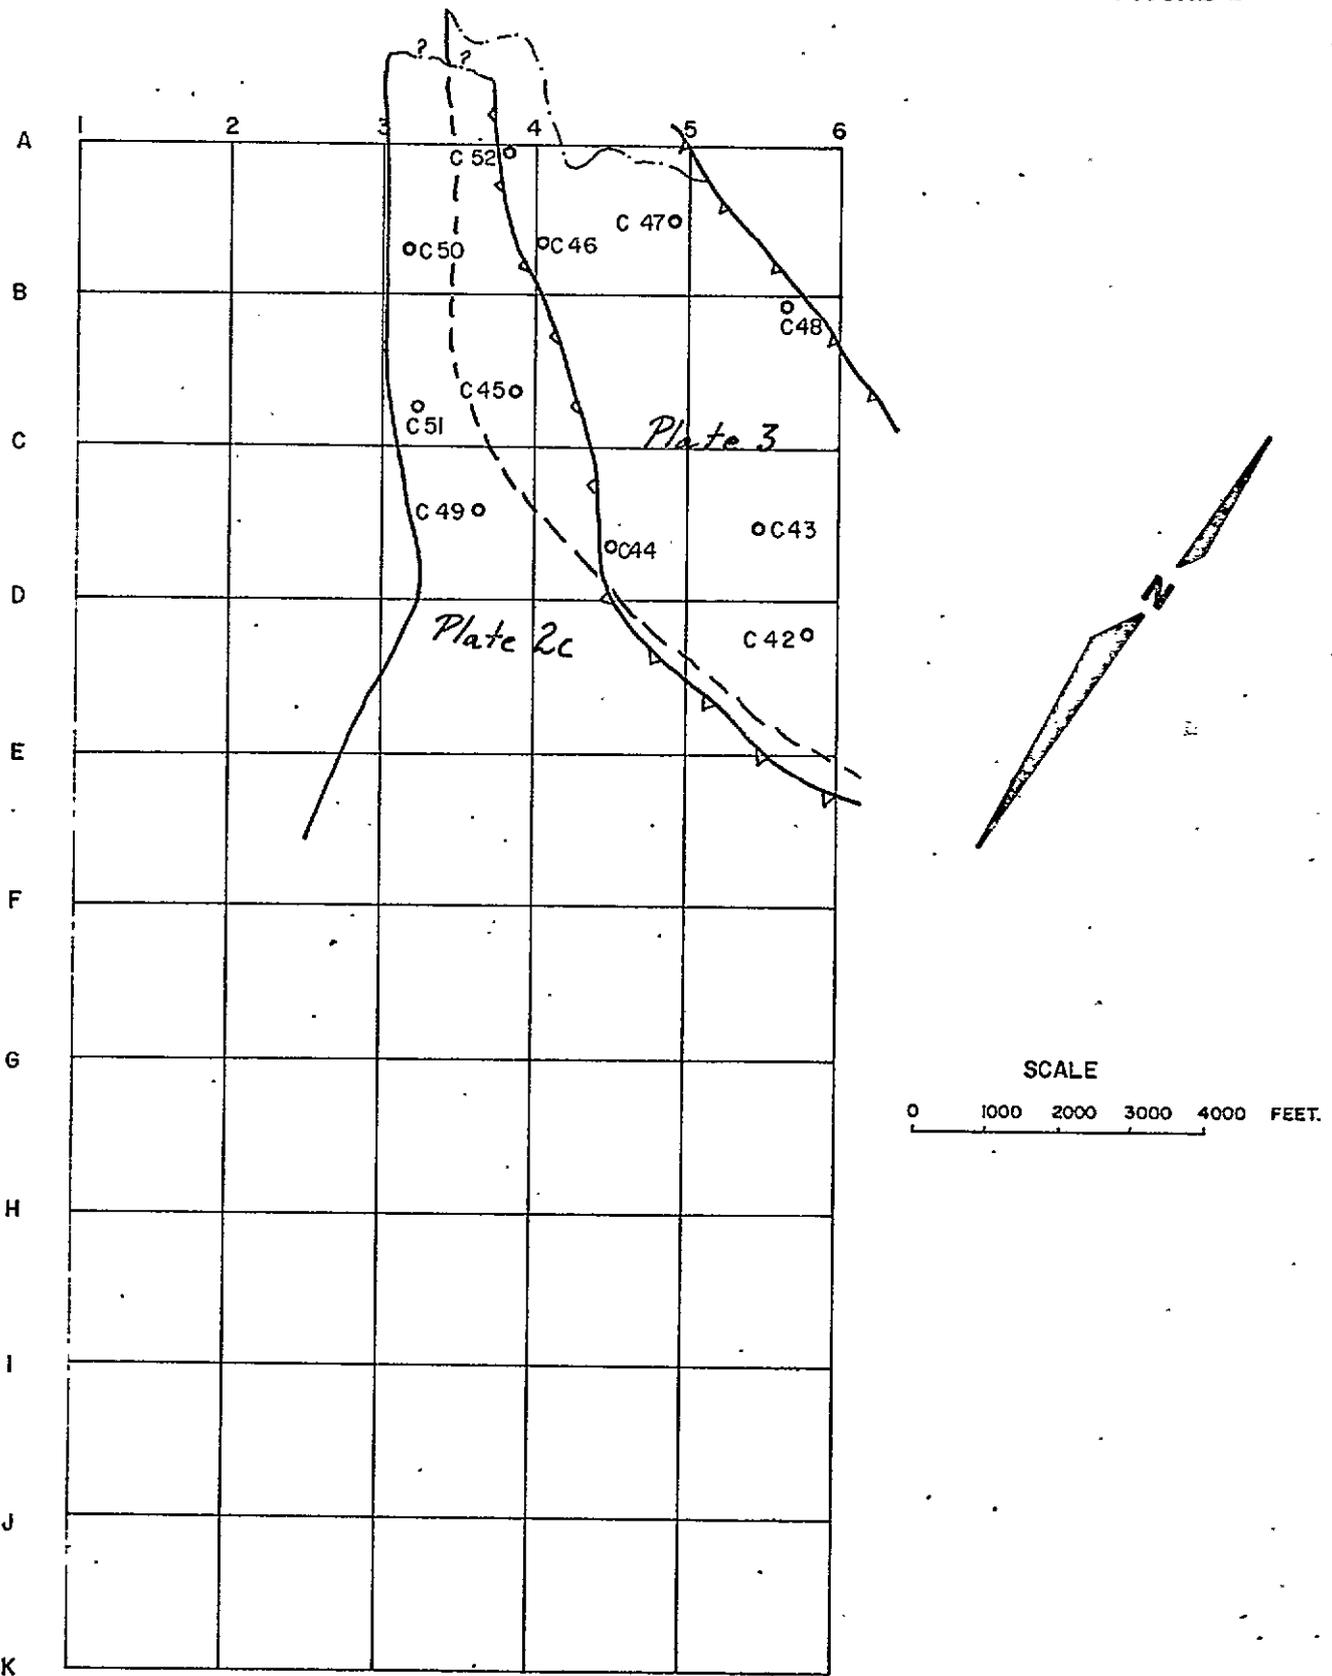
FIGURE 3.1

DRILL HOLE LOCATIONS 1972
GEOLOGICAL PROGRAMME

Five of the drill holes were located to intersect the Chamberlain Seam in Plate 2c and six were located in Plate 3. Table 3.1 and Figure 3.1 give the location of the holes drilled in the 1972 programme.

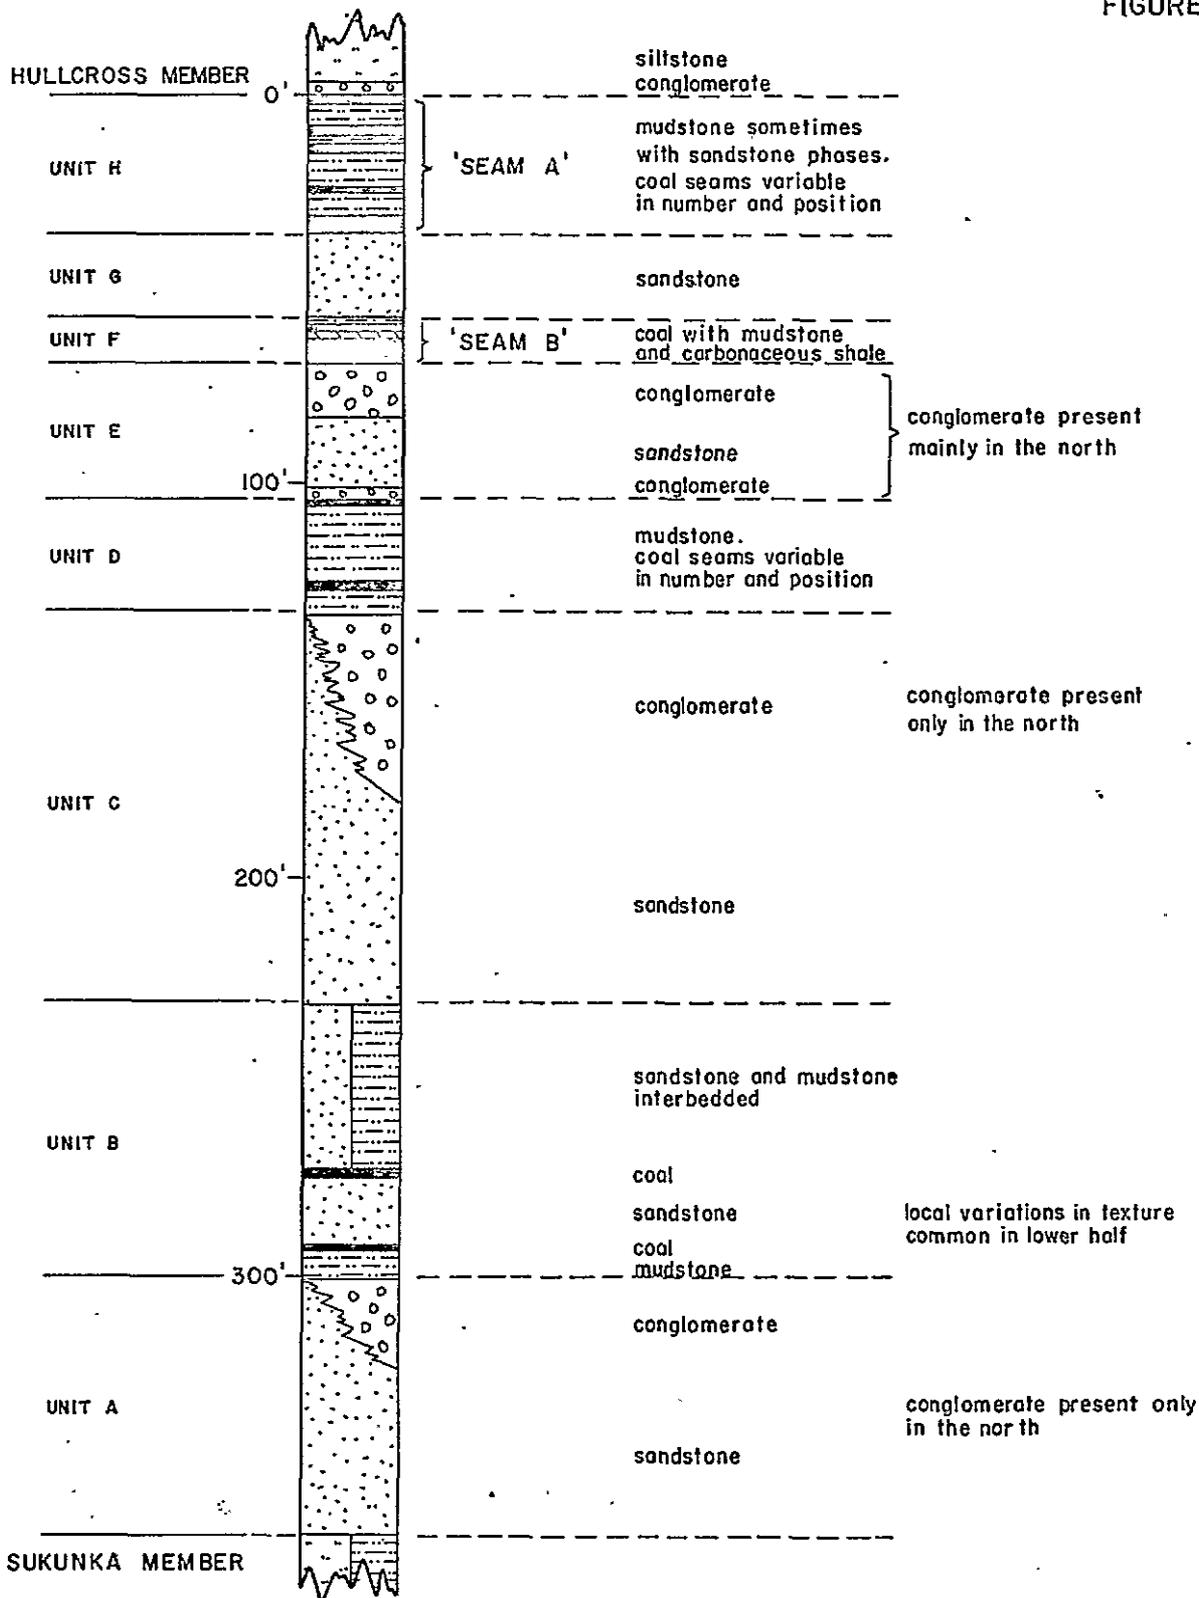
COMPOSITE GRAPHIC SECTION
OF GATES MEMBER
COMMOTION FORMATION

A seam of good quality coal was encountered towards the top of the Gates Member in D.D.H. C-42. A brief study of the stratigraphy of the Gates Member was undertaken to enable correlation of this seam with other seams encountered in previous drill holes. The results of that study, together with an appraisal of the coal seams are included in Appendix F. The

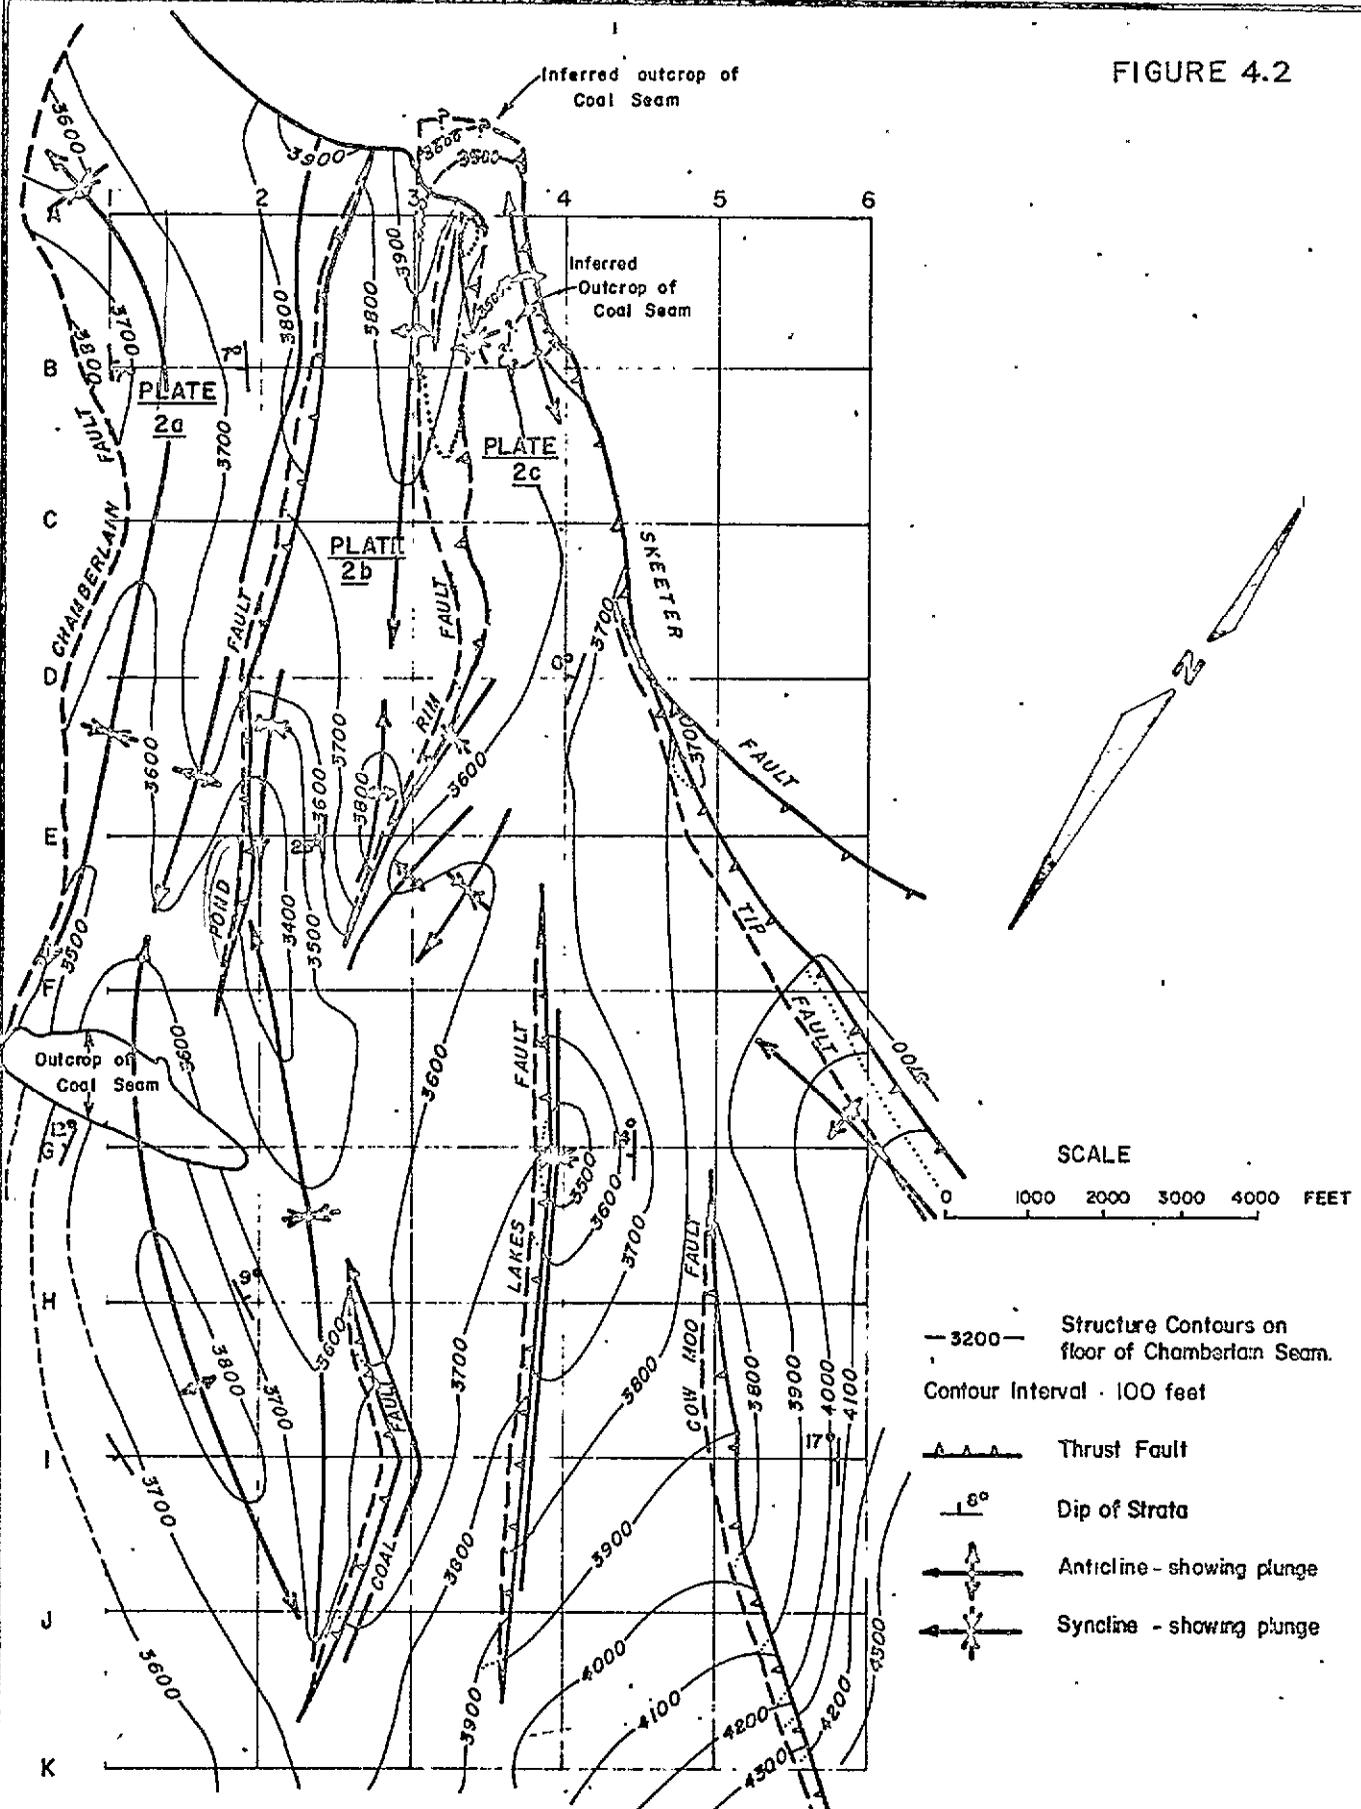
FIGURE 4.2

SKETCH MAP

REGIONAL STRUCTURAL FEATURES
PLATE 2

Plate 2c is bounded to the east by the Skeeter Fault and to the west by the Rim Fault. These features are shown on Map 7A and in Figure 4.2.

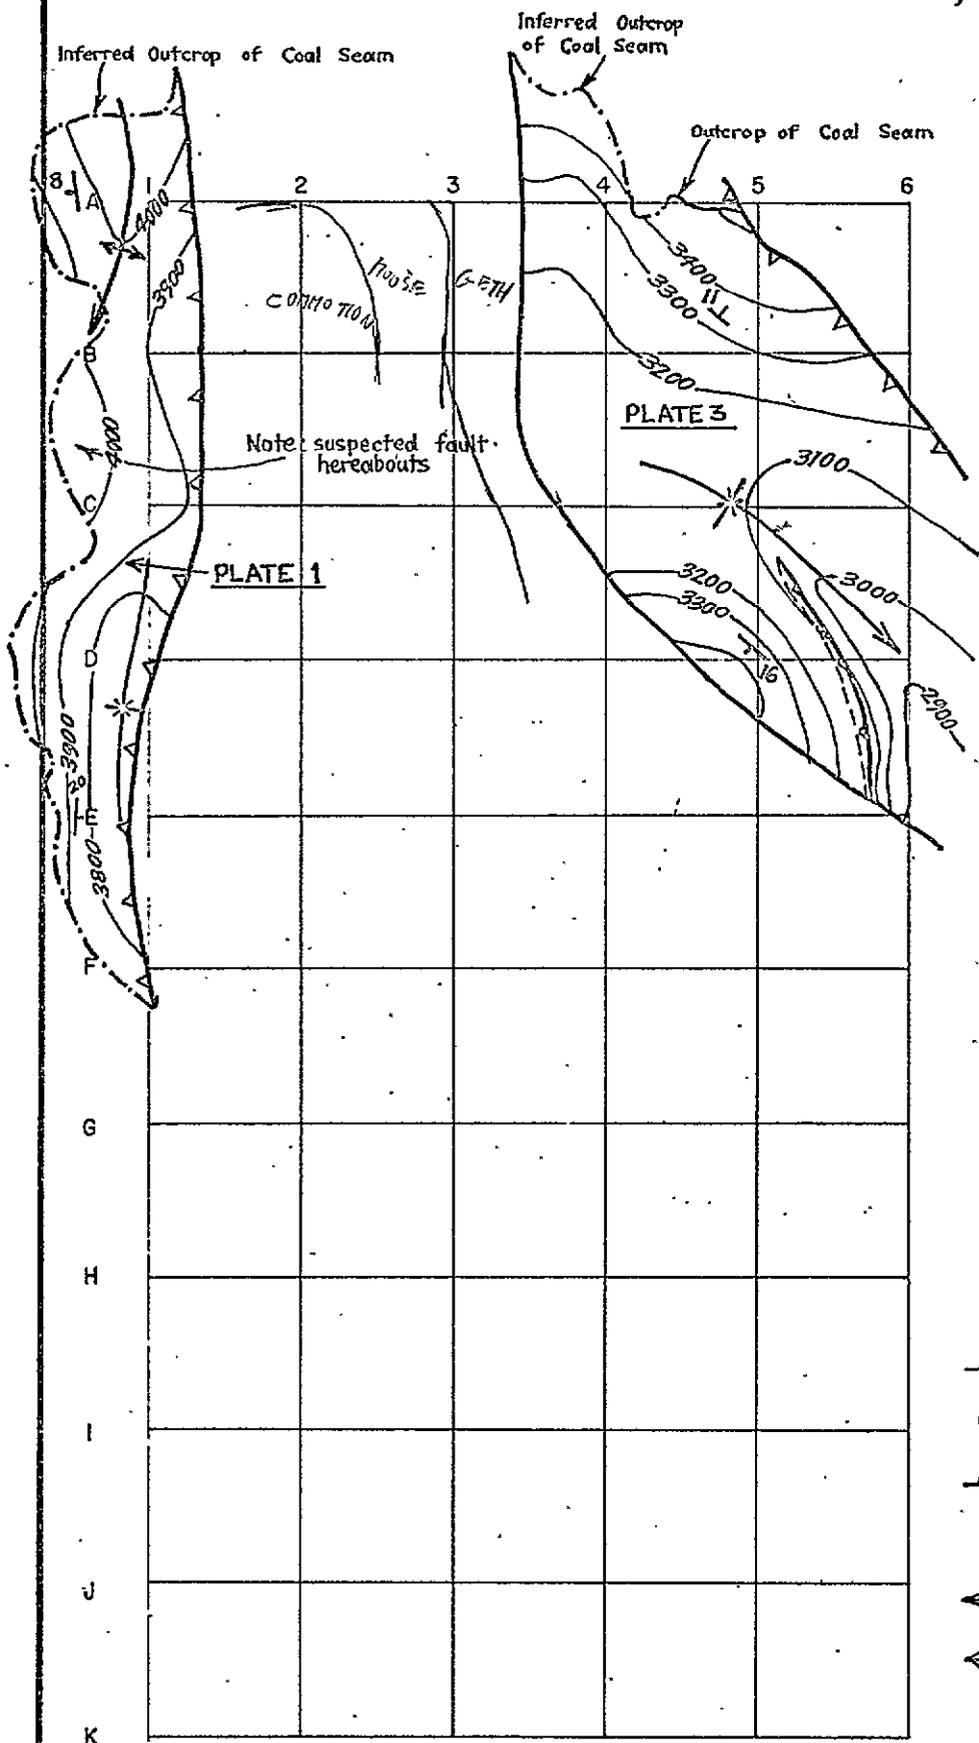
- SCALE
0 1000 2000 3000 4000 FEET.
- 3200— Structure Contours on floor of Chamberlain Seam
CONTOUR INTERVAL: 100 FEET.
 - ▲▲▲▲ Thrust Fault
 - $\frac{1}{8}$ Dip of Strata
 - ↔ Anticline - showing plunge
 - ↔ Syncline - showing plunge

SKETCH MAP

The location of the western margin of Plate 3, at the Chamberlain Seam level, has been more accurately defined by drilling, and geological mapping has enabled the attitude of the seam in the north-western part of Plate 3 to be more accurately determined.

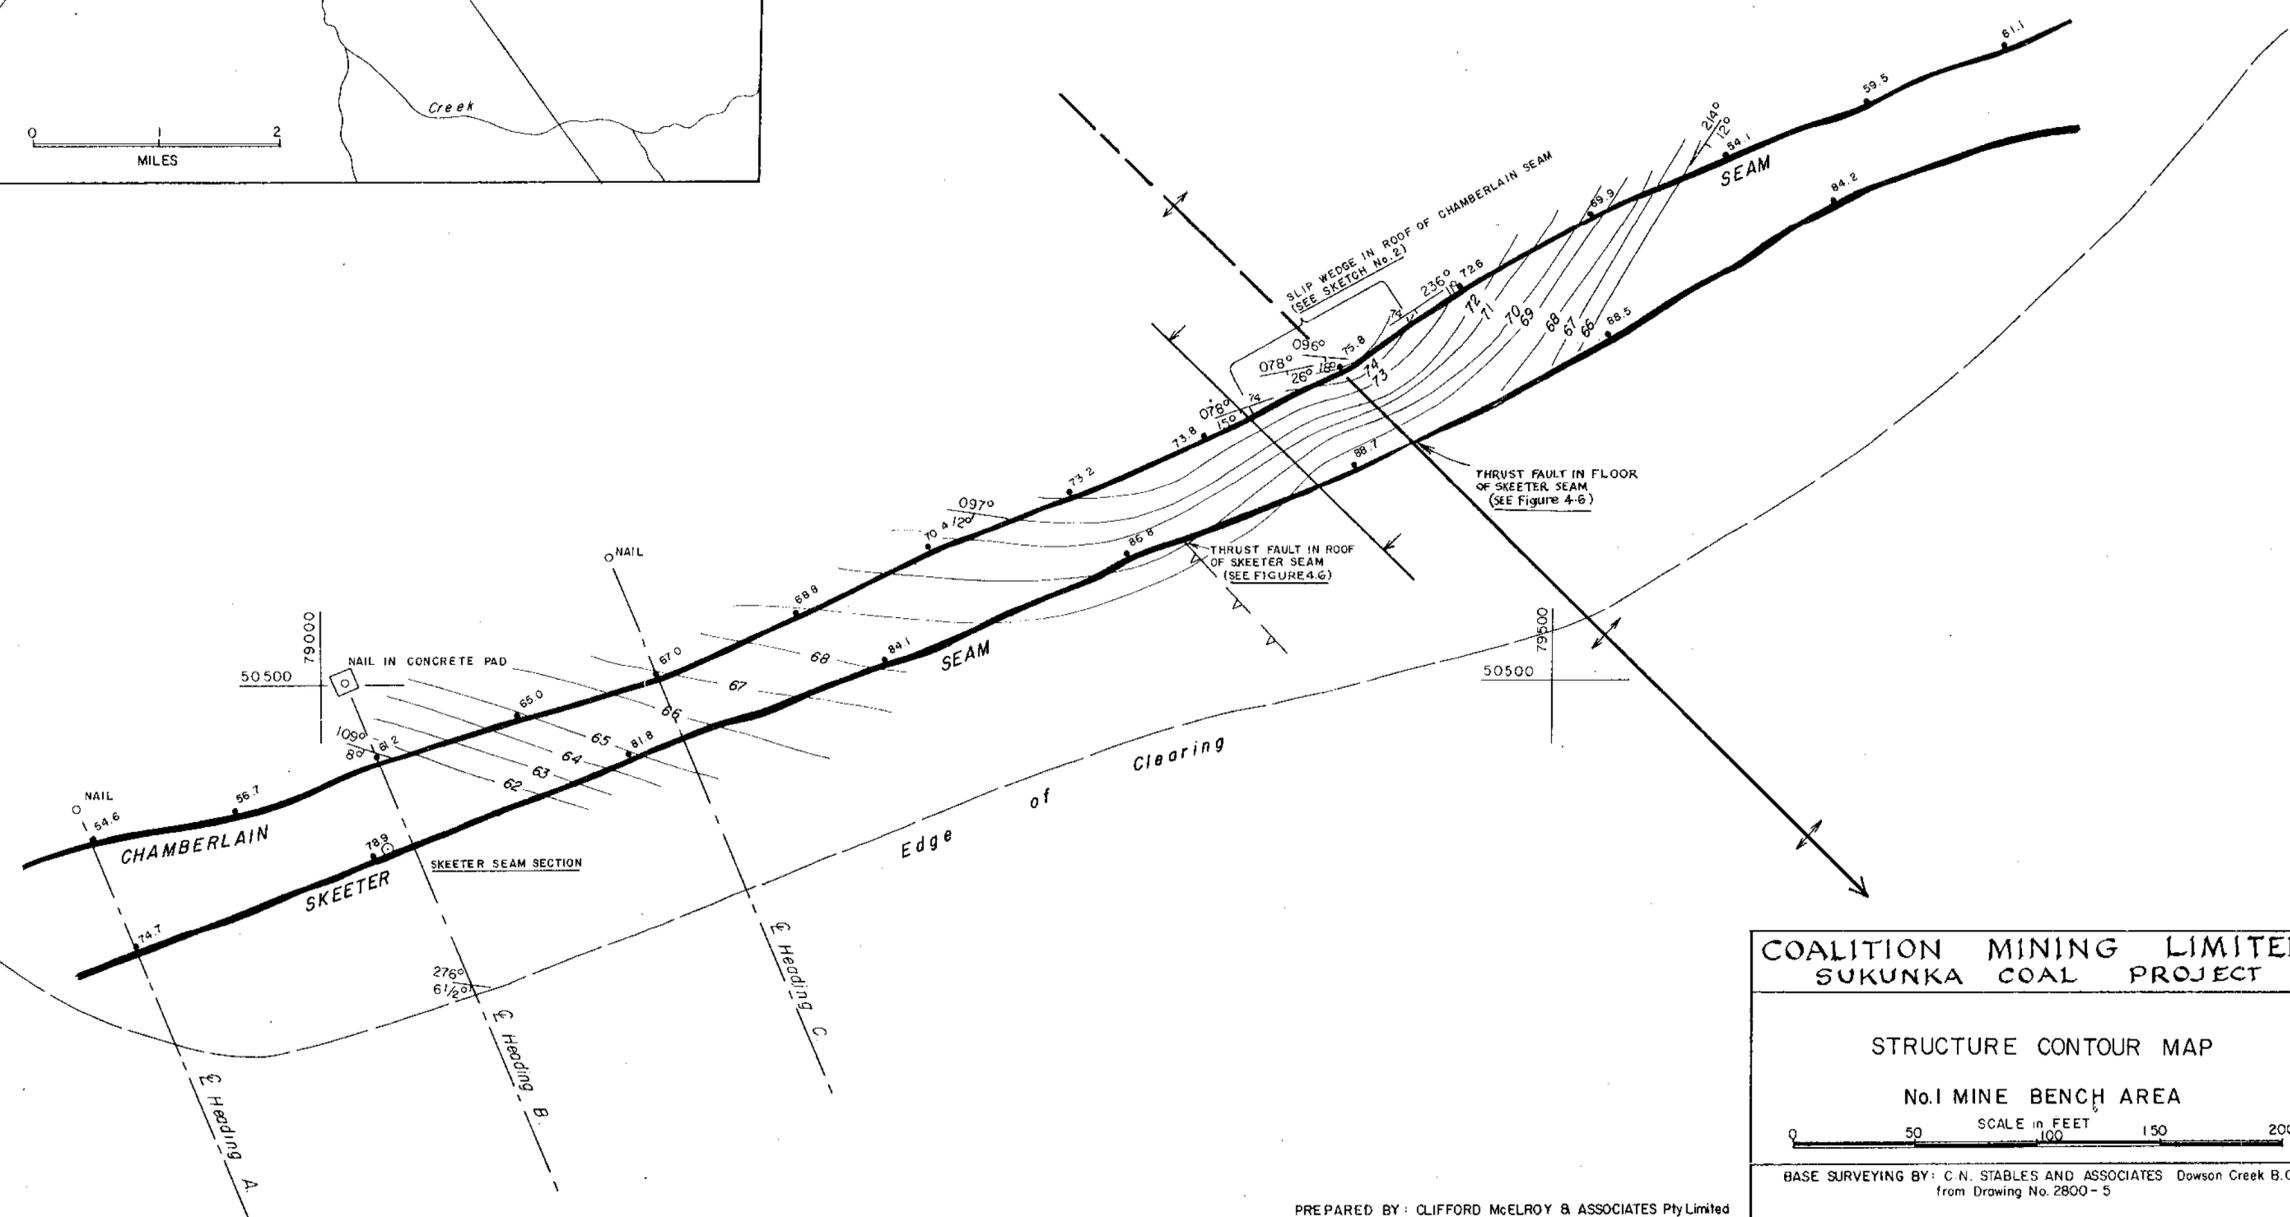
- Seam Location, diagrammatic
- 64.1 Surveyed elevations of Chamberlain Seam floor
- 68 Structure contours on floor of Chamberlain Seam - Contour Interval 1'
- 100° 17° Strike and dip - Chamberlain Seam floor
- Anticline - Hinge Line - showing plunge Trend based on stereogram
- Monocline - Hinge Line
- Thrust Fault in Skeeter Seam roof - Trend drawn parallel to stereogram structures

STRUCTURE CONTOUR MAP

The benching for No. 1 Mine and the consequent exposure of both the Skeeter and Chamberlain Seams afforded an opportunity to study some of the small scale structures which affect the coal seams and the interseam sediments. Figure 4.4 shows the outcrop of the two seams and the location of structures which are detailed in Figures 4.5 and 4.6.

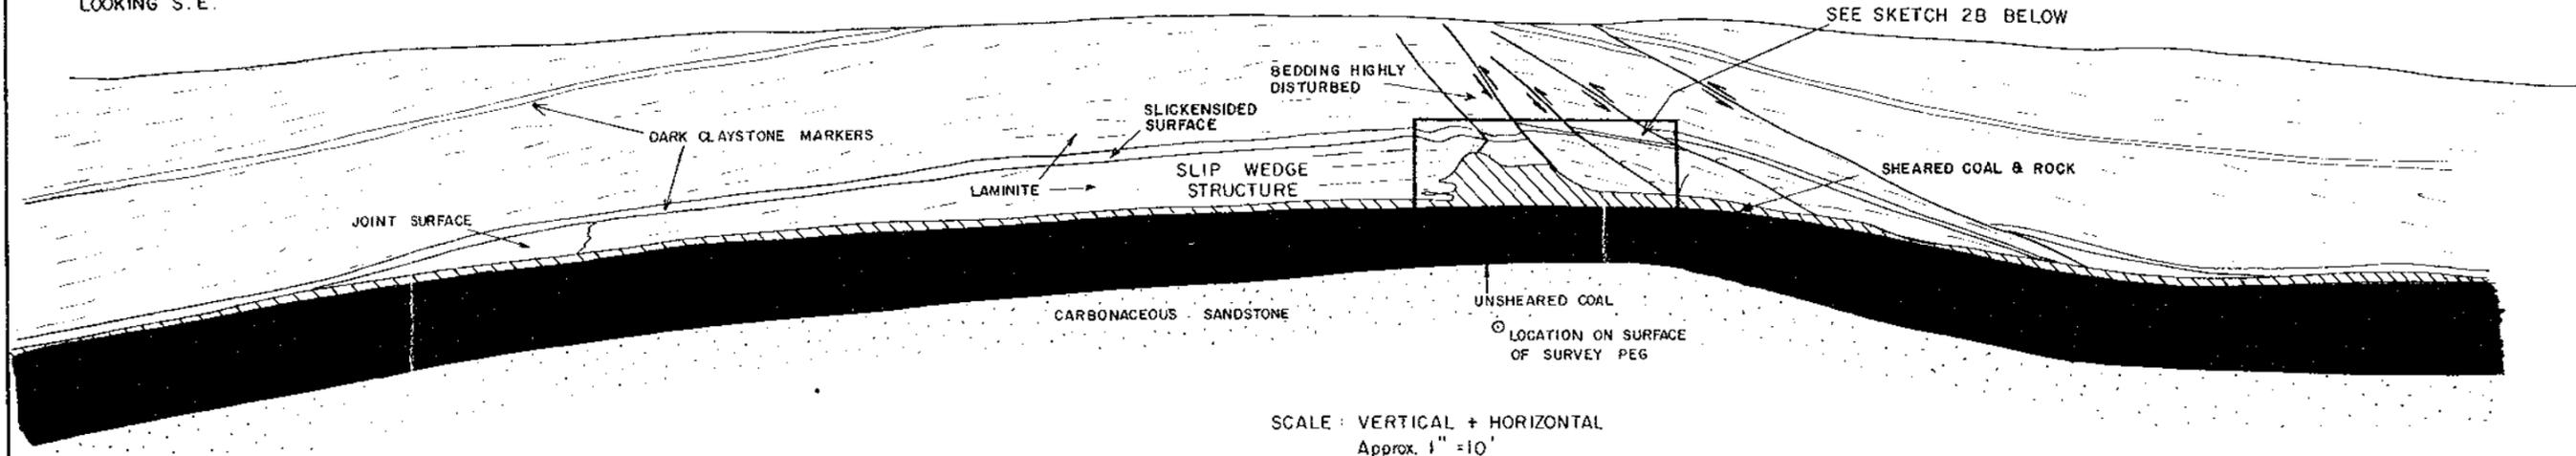
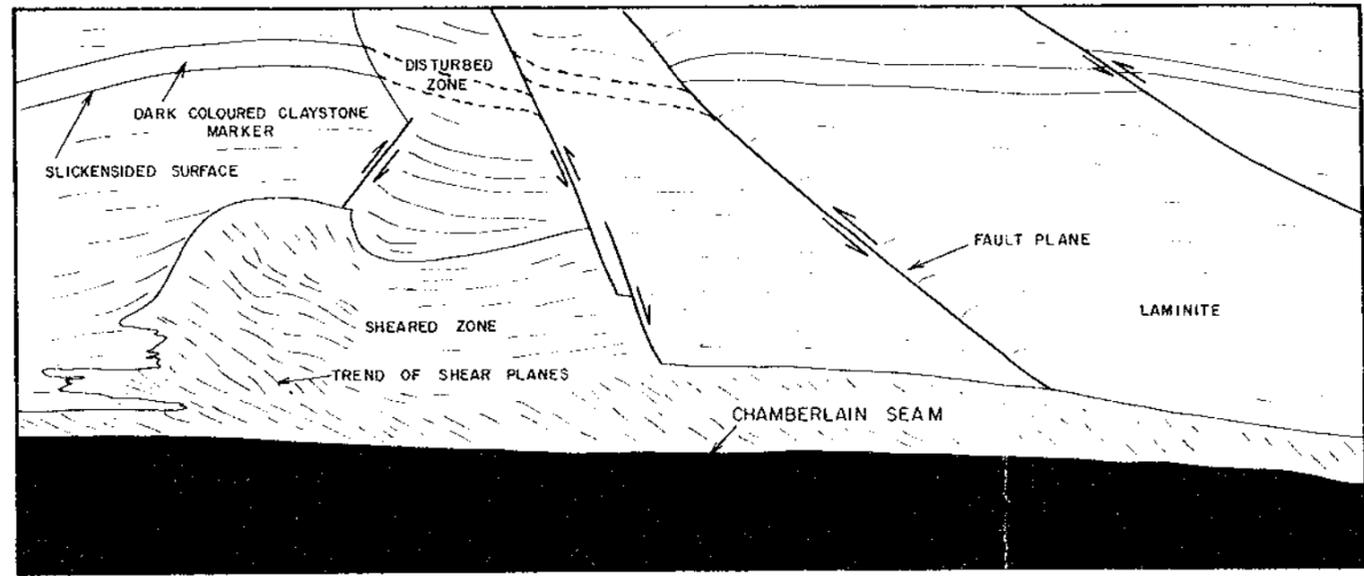
FIGURE 4.5
650

SKETCH No. 2A
LOOKING S. E.

SKETCH No. 2B
SHOWING DETAIL OF SKETCH 2A
& TRENDS OF SHEAR PLANES IN SHEARED ZONE

A local thickening of the sheared coal near the hinge of the anticline is detailed in Sketches 2A and 2B, Figure 4.5.

A 'slip wedge' of this type exists above the Chamberlain Seam in the axial region of the anticline at No. 1 Mine Site. Sketch 2A, Figure 4.5, shows the extent of the slip wedge and the nature of the structures developed within it and in the overlying strata. A thickened section of sheared coal is developed in association with this structure. Sketch 2B, Figure 4.5, is a detailed sketch of this part of the structure.

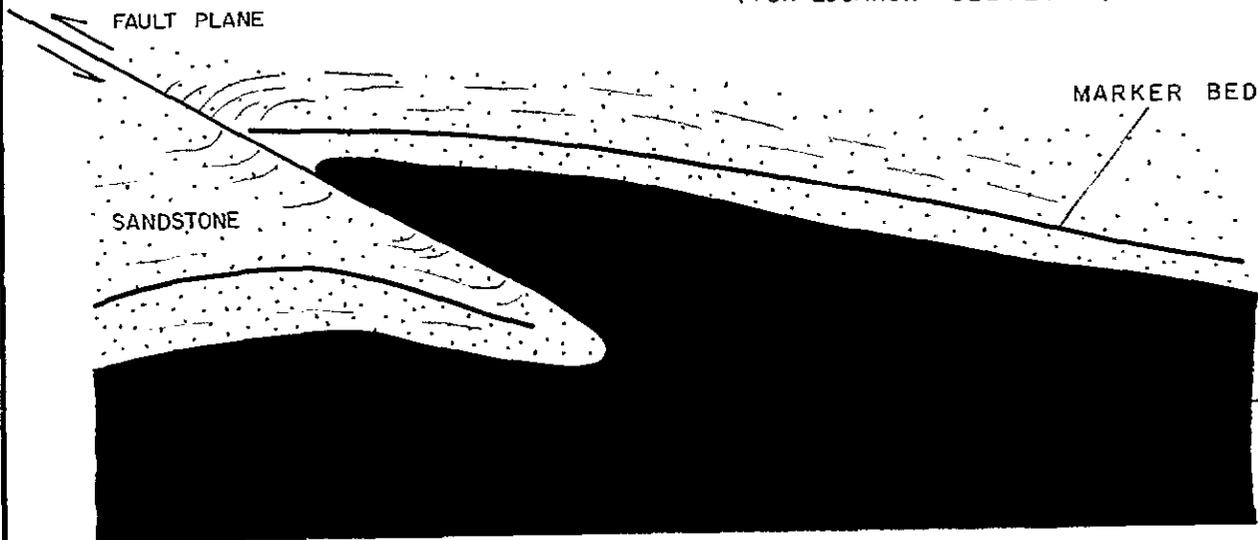
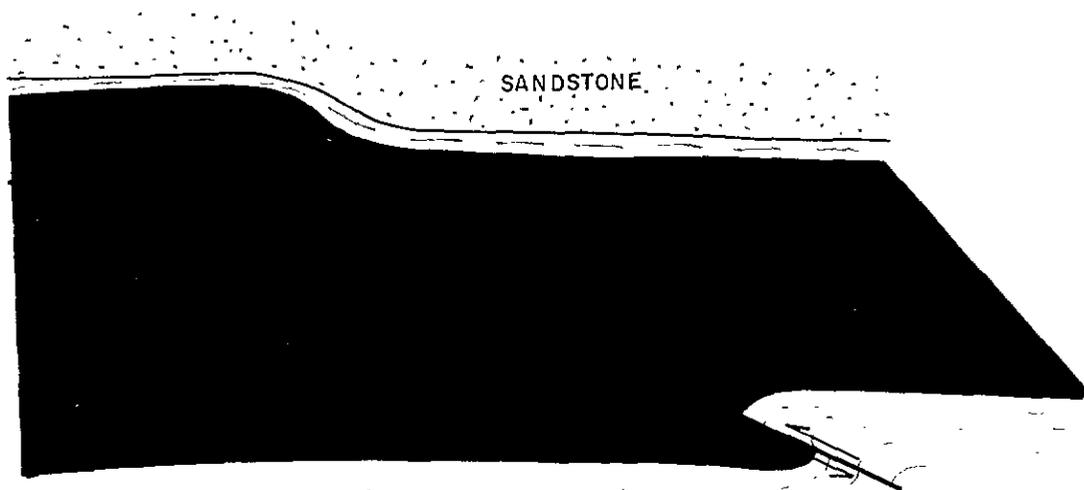
(i) SHOWING ROOF STRUCTURES - 'THRUST FAULTS'
ABOVE SKEETER SEAM

(ii) THRUST FAULT - FLOOR OF SKEETER SEAM

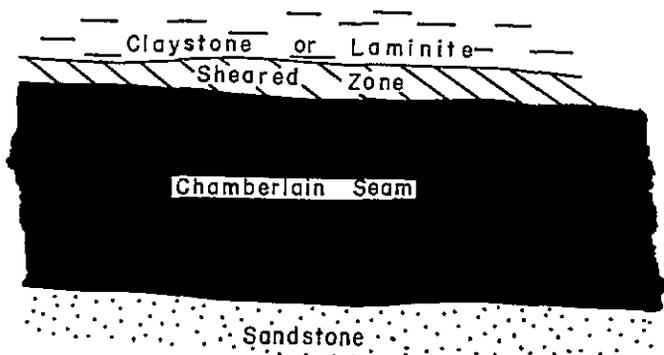
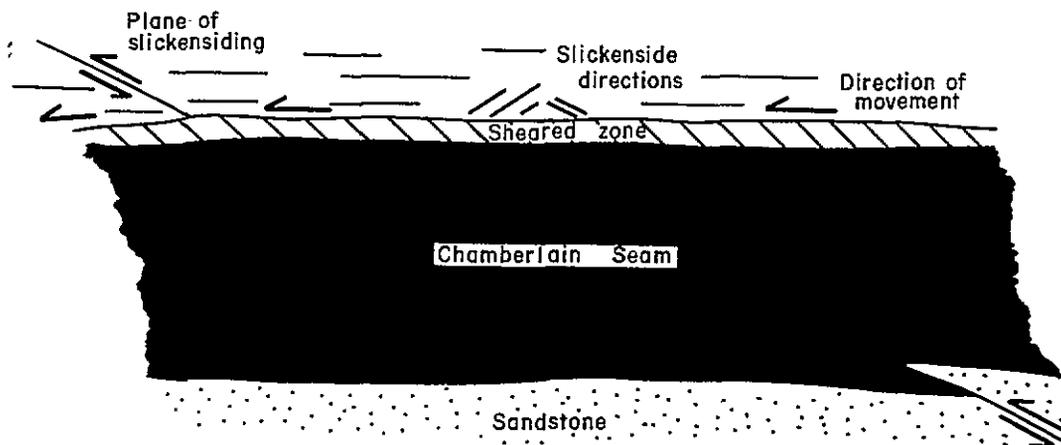
DIAGRAM A

DIAGRAM B

Bending and attenuation of the ends of each slice tends to suggest the relative direction of movement of rocks on either side of this structure as is shown in Figure No. 4.7, Diagram B.

These relationships are illustrated in text Figure 4.7, Diagram B.

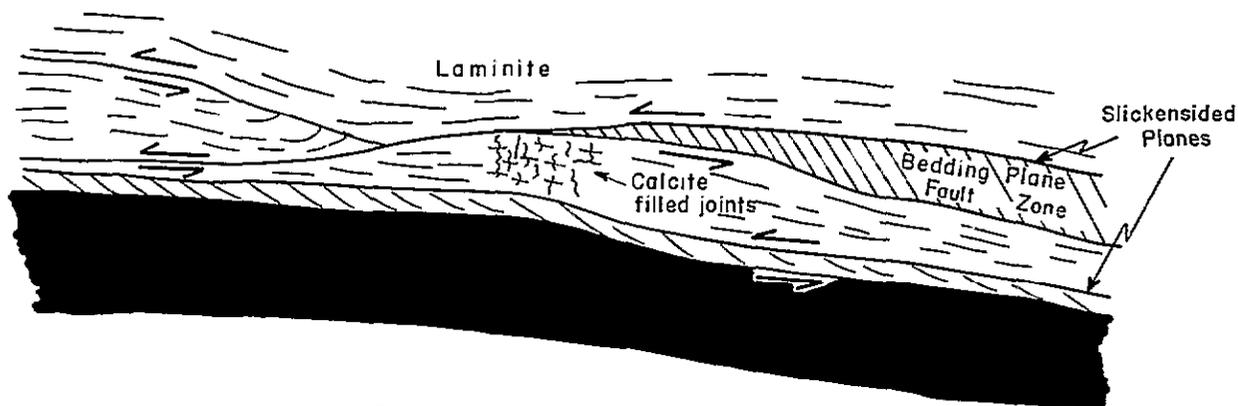
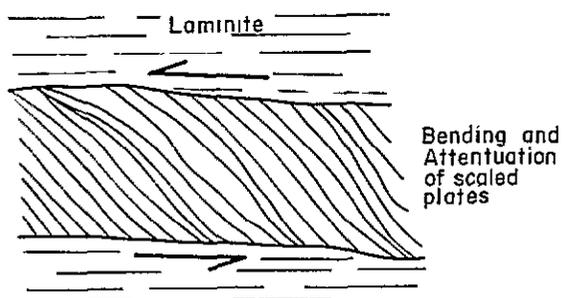
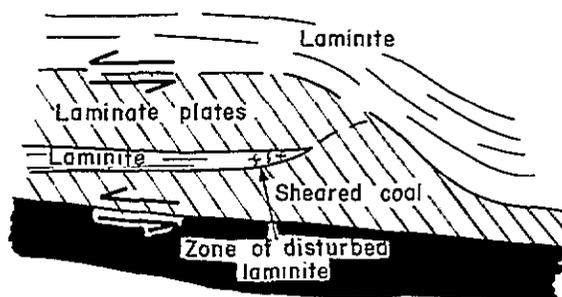
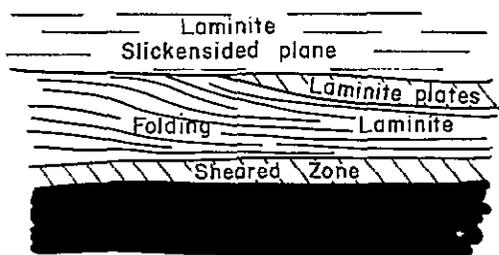
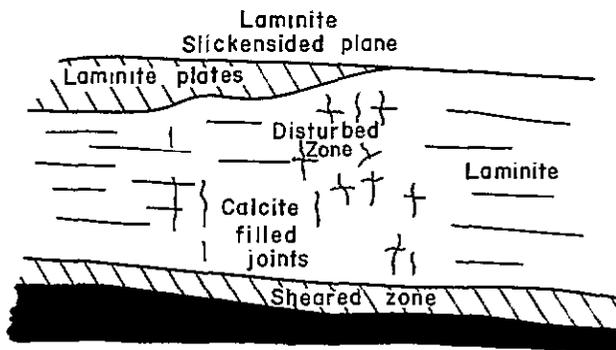
RELATIONSHIPS AT FRONT OF SLIP WEDGE

DETAIL OF WEDGE ZONE

TERMINATION OF SLIP WEDGE

MARGIN OF WEDGE

The zone of shearing at the top of the seam occurs immediately below the laminite roof rock and varies in thickness between 0.22 and 0.67 feet. Figure 4.8, Diagram A shows the relationship of the sheared zone to the coal seam and roof rock. This sheared zone has been observed throughout the workings of the mine. It consists of sheared fragments of coal and rock. In much of this zone there are sheared fragments of the "bone" layer which is defined as "stone, coaly".

In the second case, the volume is accommodated by movement along closely spaced sub-vertical fractures as opposed to folding. These fractures trend 108° . These relationships are shown in text Figure No. 4.8, Diagrams A to E.

One very minor dislocation of the floor to date in Mine No. 1 is described in Section 4.4.5(iii) and is illustrated in Figure 4.8. The fault has a throw of 0.8 feet but the lateral movement could not be determined. No dislocation of the roof occurred nor could the fault be traced into the seam. In the roof, slickensided surfaces were noted which have a relationship to the fault and are fully described in the above mentioned section.

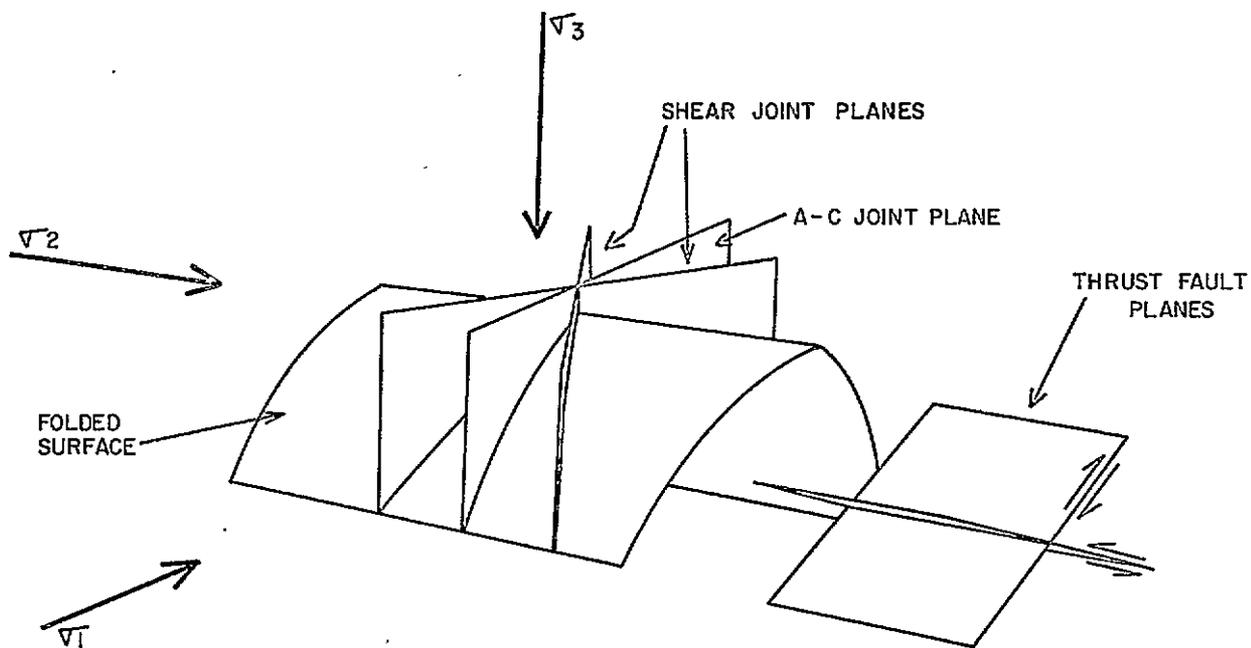
THEORETICAL RELATIONSHIP OF STRUCTURES
TO THE GENERATING STRESS SYSTEM

The other principal stresses are orthogonal to the maximum principal stress direction. This relationship in the case of thrust faulting illustrated in Figure 4.8 (modified after Price 1966).

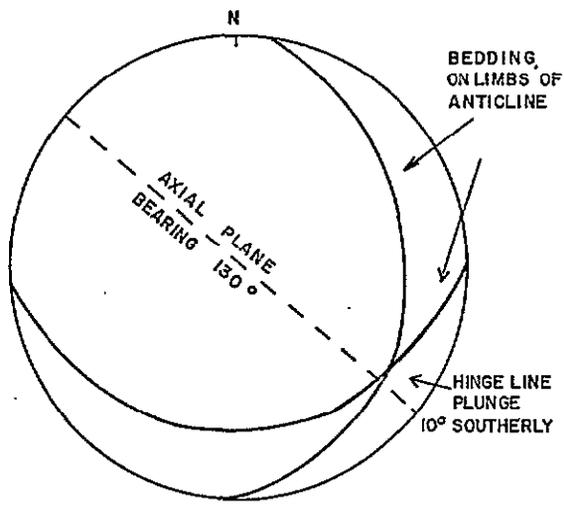
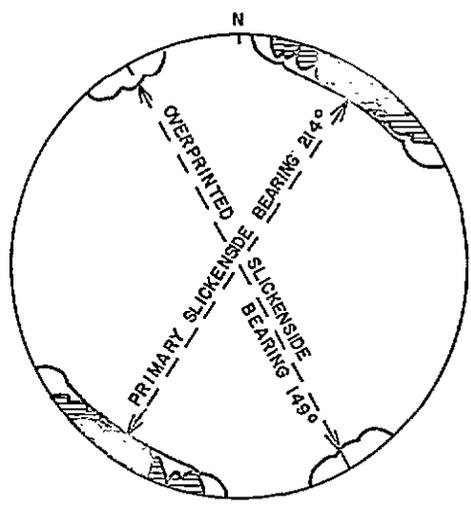
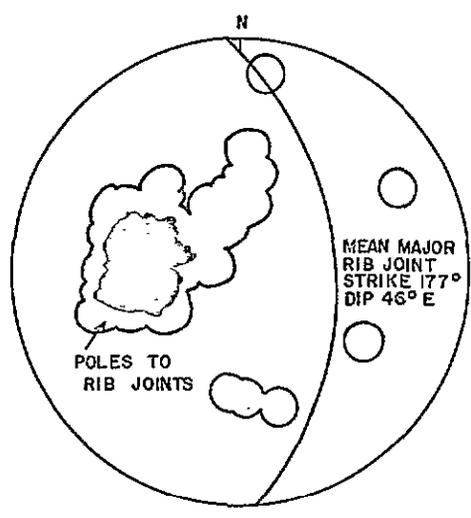
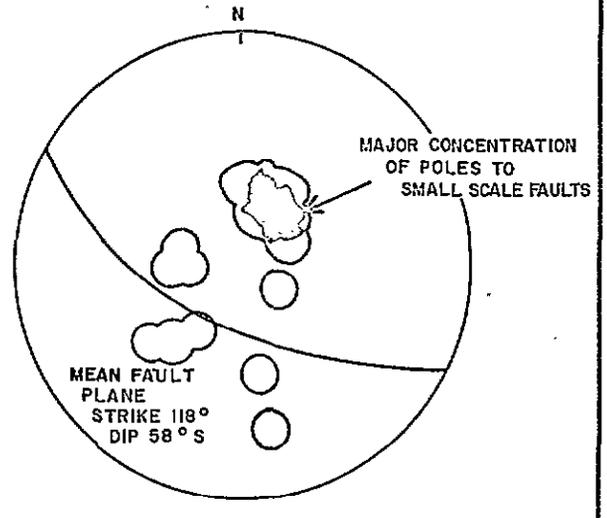
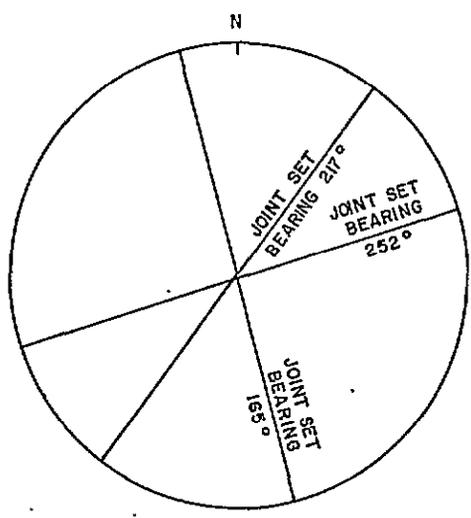
STEREOGRAM A

STEREOGRAM B

STEREOGRAM C

STEREOGRAM D

STEREOGRAM E

Stereogram A shows bedding planes measured at the surface in the immediate vicinity of Mine Site No. 1. This data has been measured on the floor of the Chamberlain Seam.

This plot defines a broad anticline with a vertical axial plane striking 130° and axis plunging approximately 10° southerly.

Stereogram B is a plot of the bearing of the first and second order slickenside directions inscribed on the Chamberlain Seam roof; the two directions are 214° and 149° respectively. The set bearing 214° is observed to be the most obvious set.

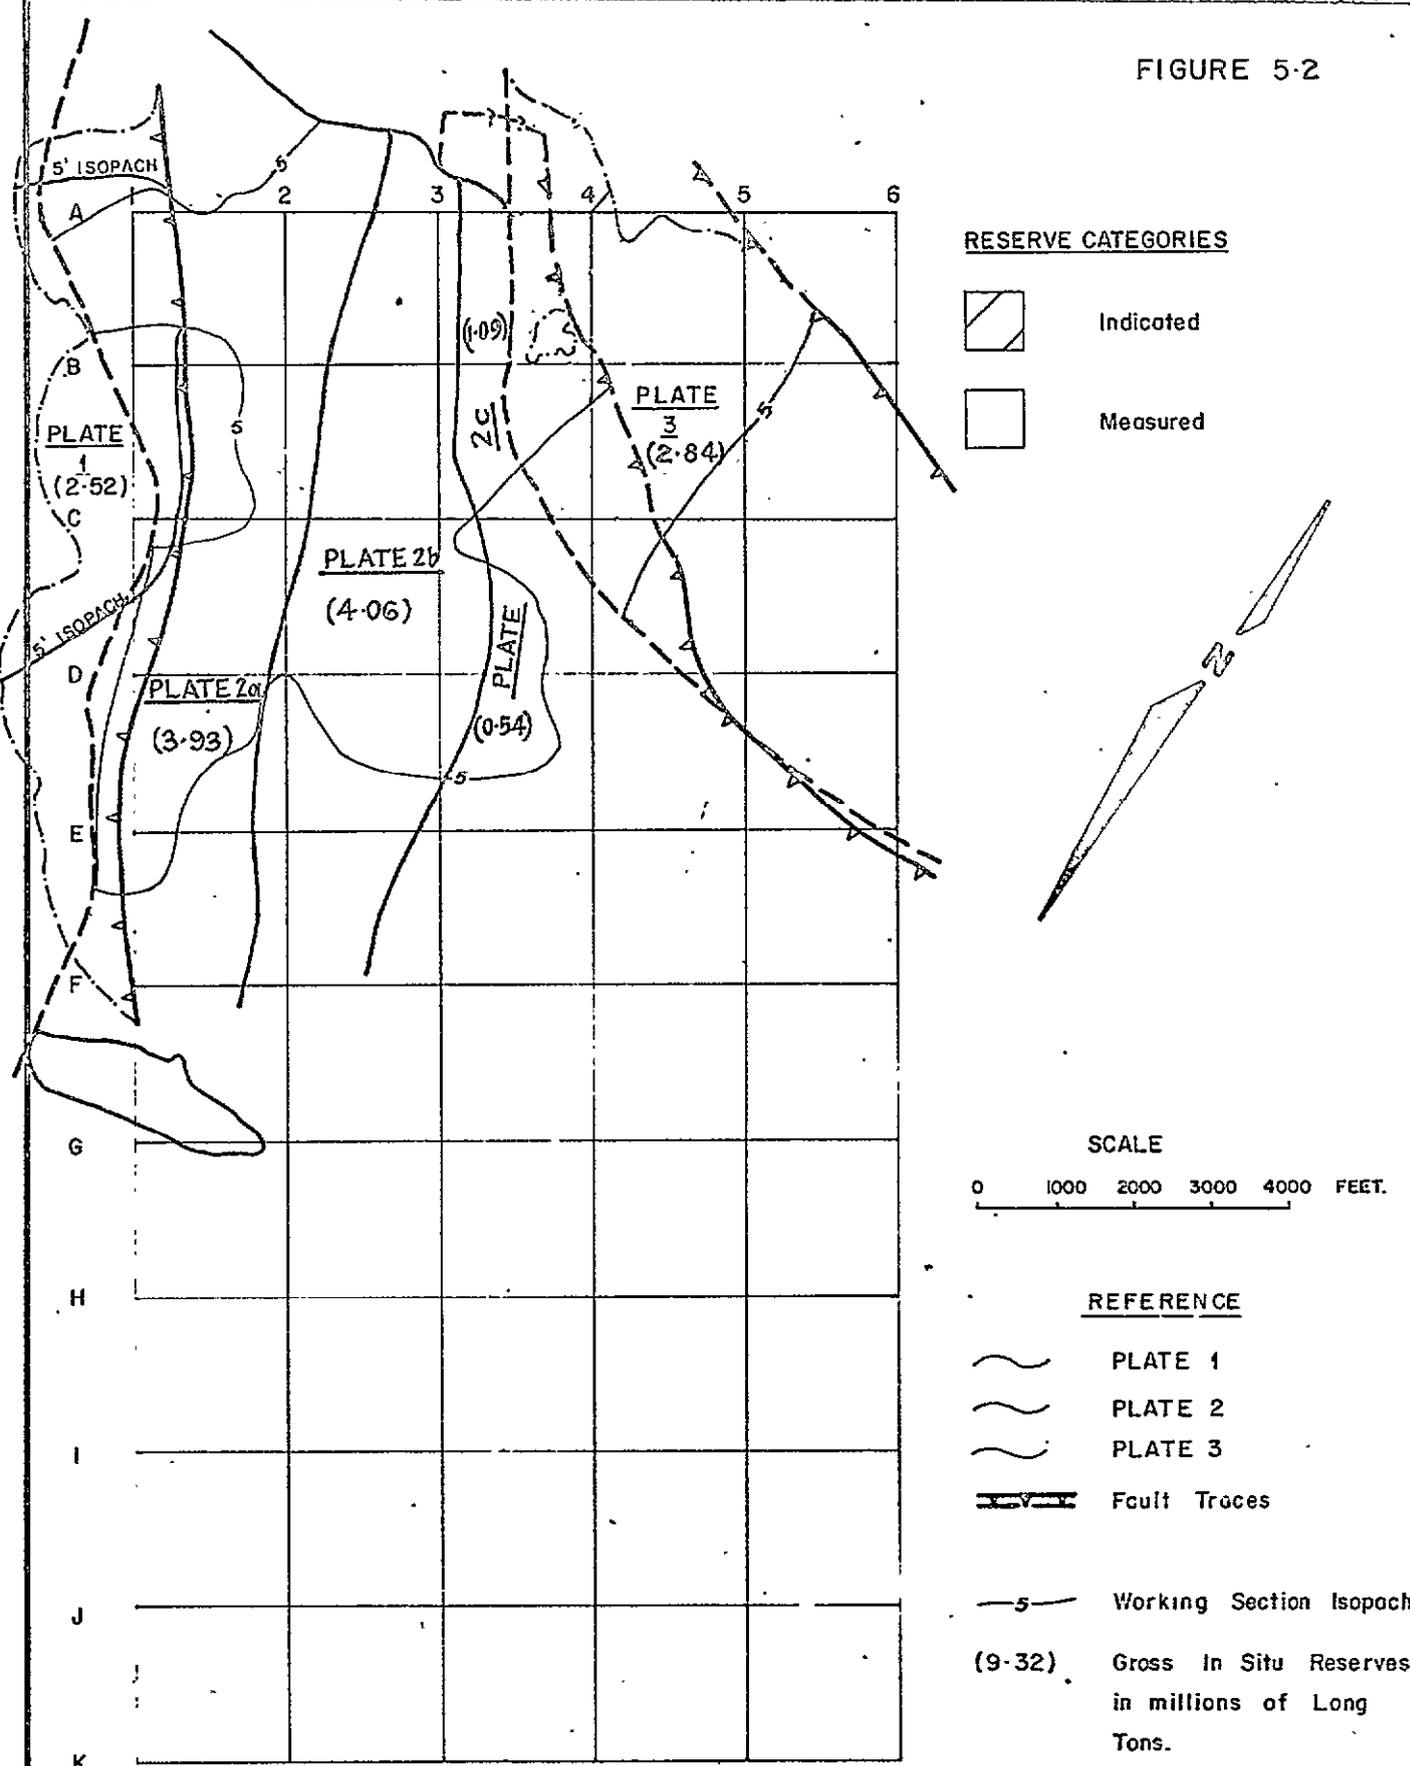
FIGURE 5-2

SKEETER SEAM (WORKING SECTION)
 PLATE BOUNDARIES AND AREAS OF
 RESERVE CALCULATION
