COALITION MINING LIMITED
SUKONKA COAL PROJECT
GEOLOGY
VOLUME 1 SUPPLEMENT

SUKUNKA COAL PROJECT

GEOLOGICAL REPORT

1972 SUPPLEMENT

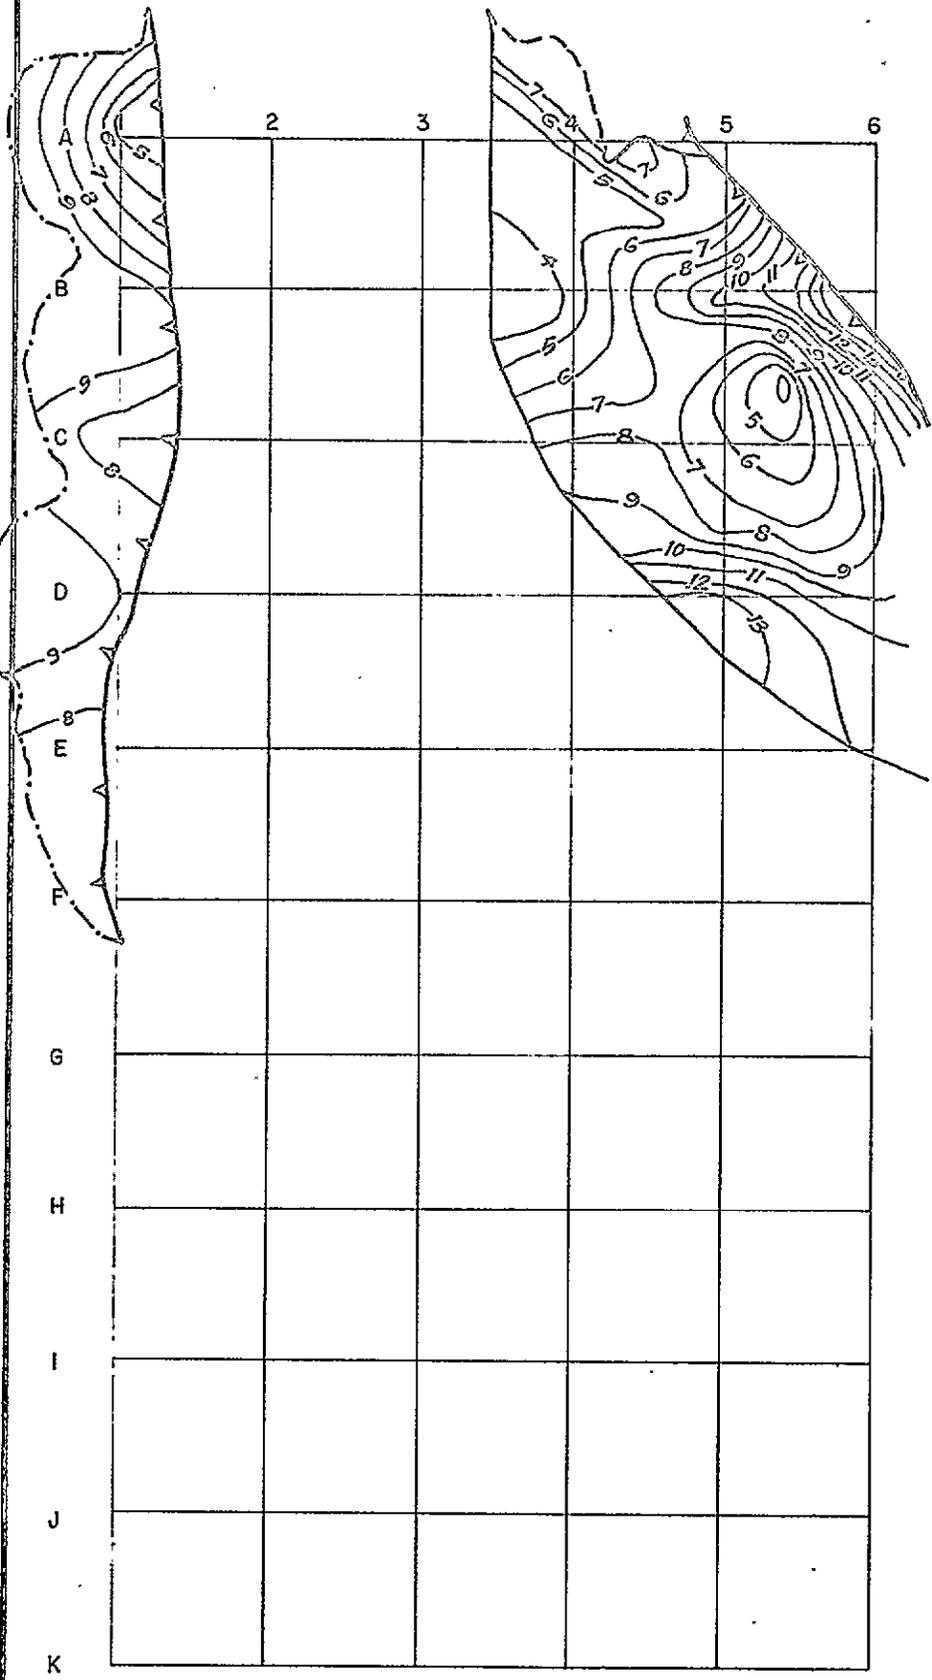
CONTOUR INTERVAL: 1 FOOT.

SKETCH ISOPACH MAP
CHAMBERLAIN SEAM
PLATES 1 & 3

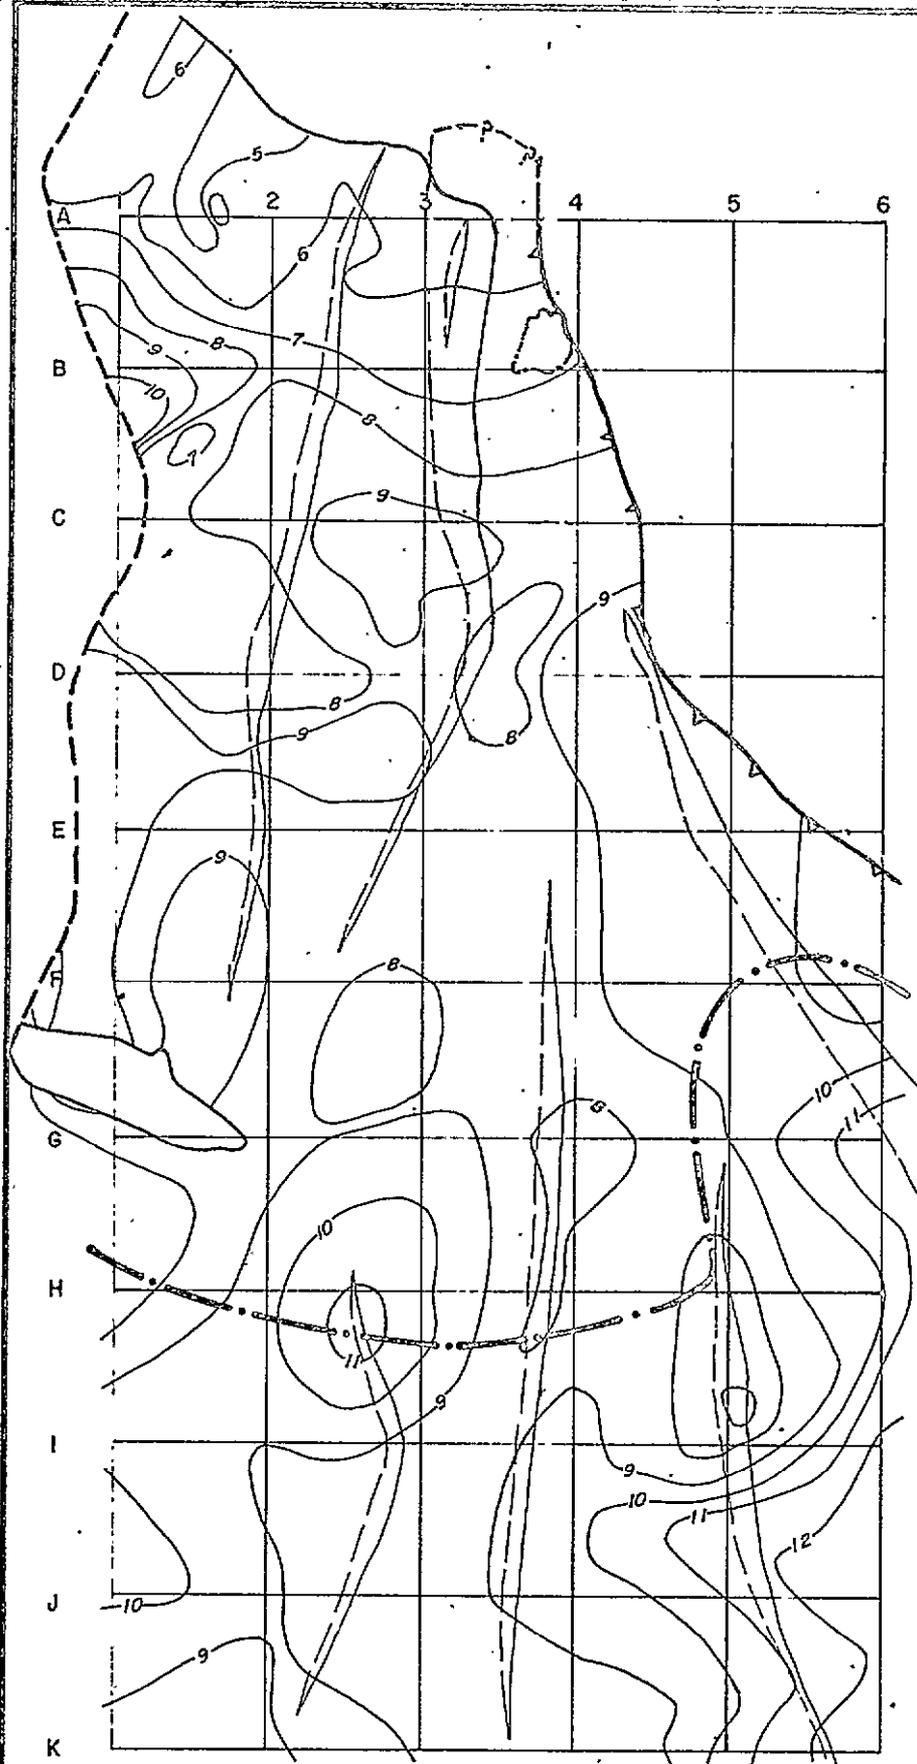
FIGURE 5.9

CONTOUR INTERVAL: 1 FOOT.

The Chamberlain Seam thickness varies from less than 5 feet in the north to in excess of 10 feet in the vicinity of grid line B; most of the plate is in excess of 7 feet. Variations in the coal seam thickness in Mine No. 1 are shown on Map 31. It is not anticipated that the seam thickness will reach 7 feet until some 2,500 feet south of the outcrop. See Map 10A and Figure 5.9.

The Chamberlain Seam thickness varies from 6 feet in D.D.H. C-6 in the north to 9.39 feet in D.D.H. S-7 to the south, see Map 10A and Figure 5.9.

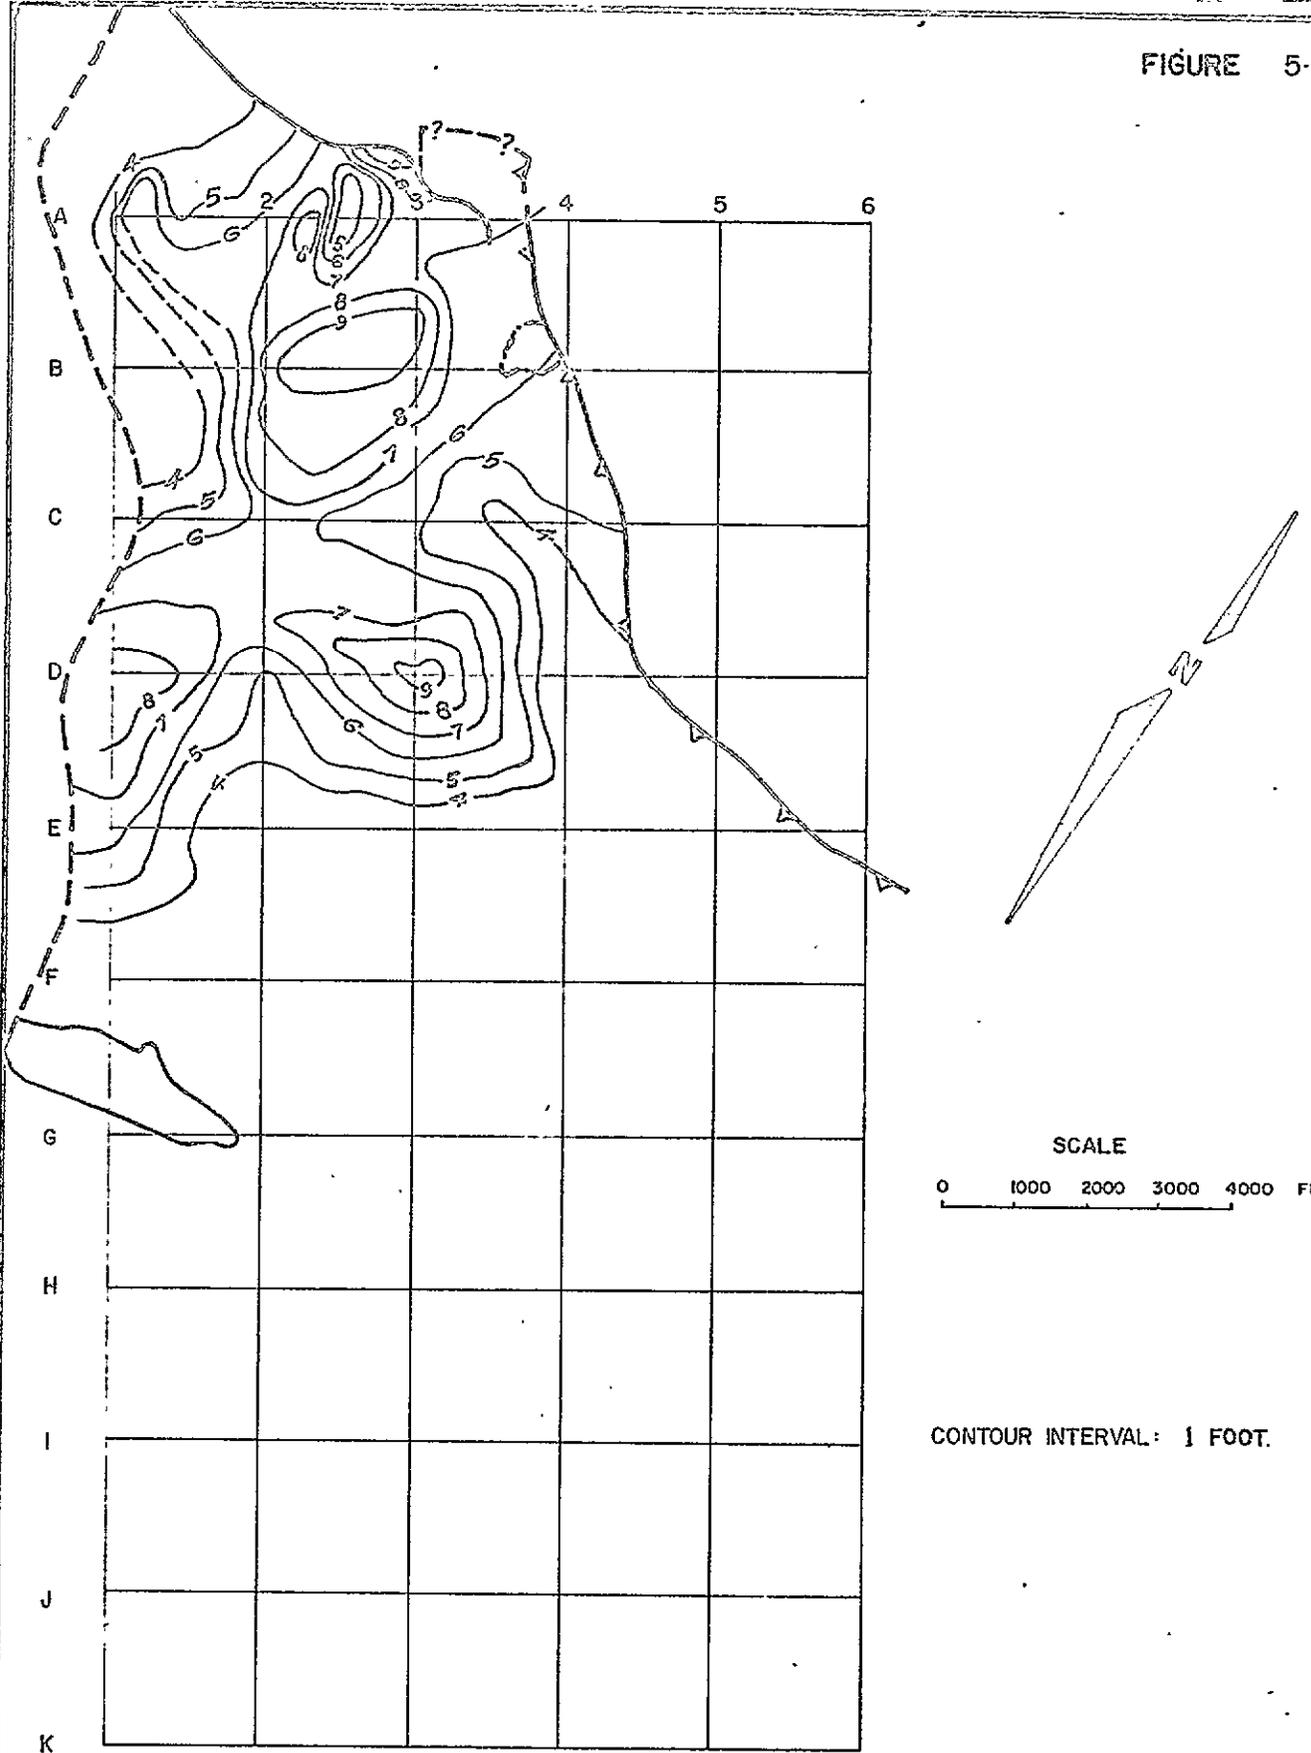
SKETCH ISOPACH MAP
SKEETER SEAM
THEORETICAL WORKING SECTION
PLATE 2

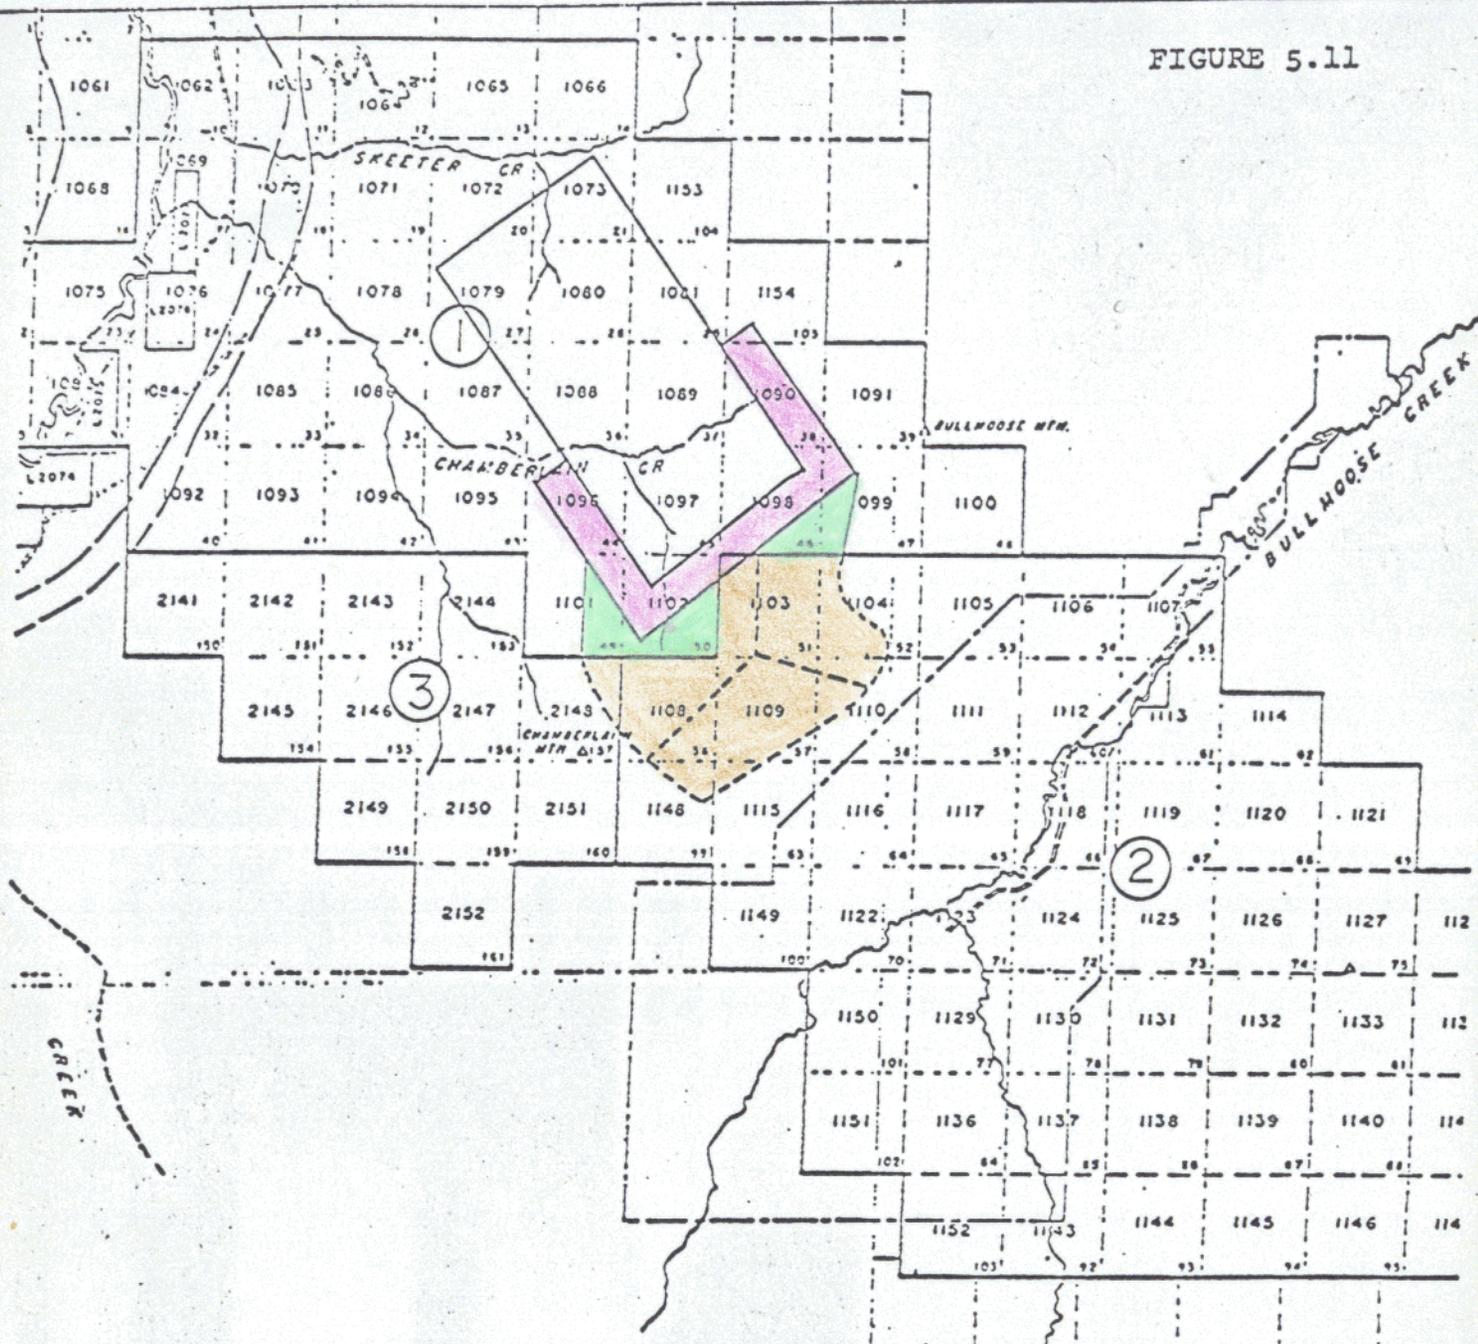
FIGURE 5.11

Area	REFERENCE Reserves*	Status

Text Figure 5.11 shows three areas which may be considered external to the currently explored area. Within these areas, only the Chamberlain Seam is of economic thickness.

External to Area A, above and south to the boundary of the current 41 licence exploration area, a further 16 million long tons of Inferred Gross Reserves exist, shown as Area B on Figure 5.11.

There are indicated gross reserves of 22 million long tons of coal in the Chamberlain Seam in an area marginal to the exploration grid shown on Figure 5.11 in Section 5 of this report. An extended drilling programme is recommended to more accurately establish the resources of coal and to more fully ascertain the structure at the level of the Chamberlain Seam.

A further 16 million long tons of coal are inferred to exist within the group of 41 coal licences held by Coalition Mining Limited, in the area shown on Figure 5.11. The results of the extended drilling programme recommended above should be assessed before drilling is extended to the boundary of the coal licence area.

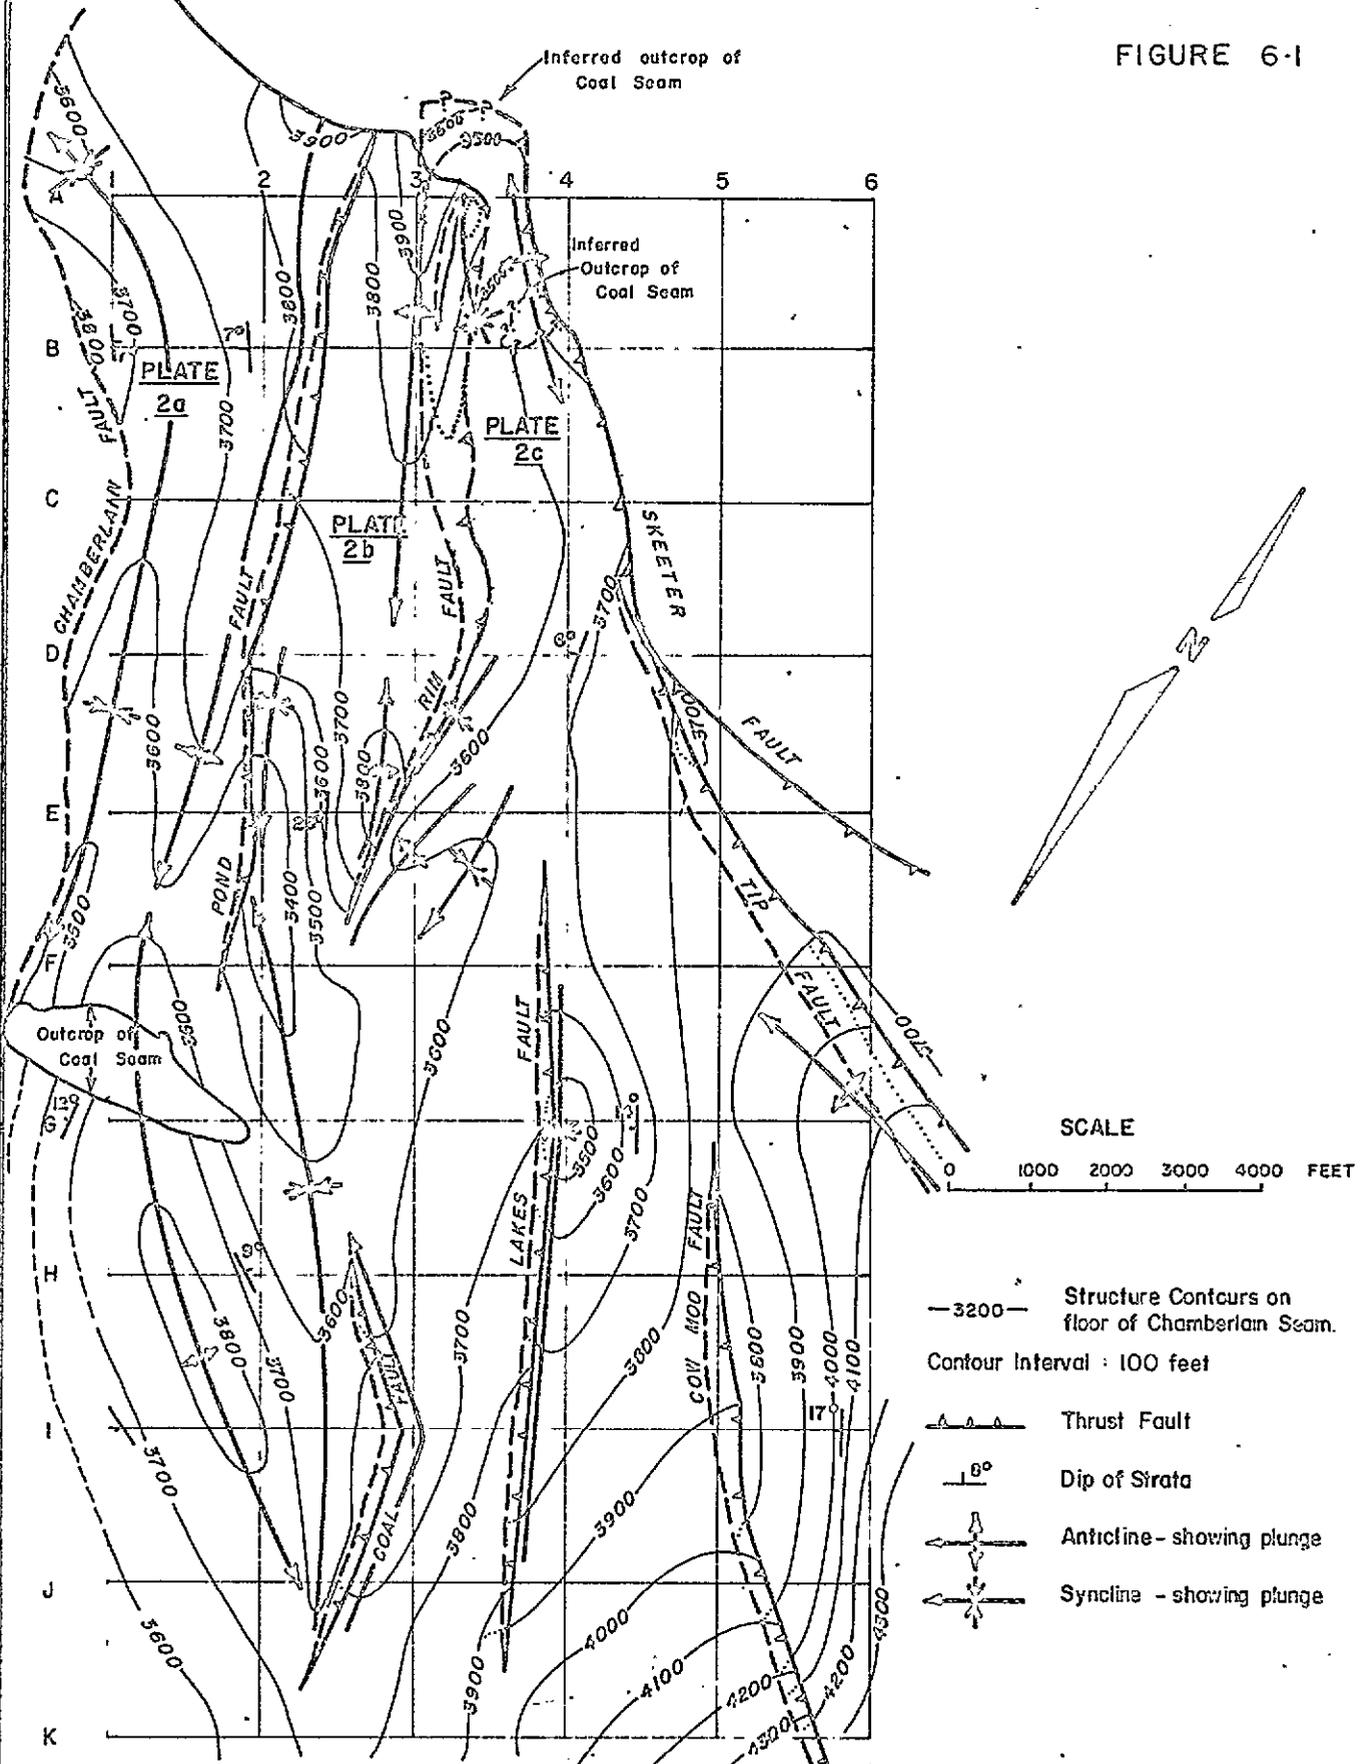
SKETCH MAP
 REGIONAL STRUCTURAL FEATURES
 PLATE 2
 AT CHAMBERLAIN SEAM LEVEL

SEE MAP 7A FOR DETAILED STRUCTURE CONTOURS

The project area is divided into 3 gross features which have been termed "Plates" (Plates 1, 2 and 3) the boundary of these plates being defined by major over-thrust faults.

The northern part of the largest of the 3 plates, Plate 2, is divided into 3 sub-plates, Plates 2a, 2b and 2c, by two intra-plate faults. The southern limit of these plates has been set

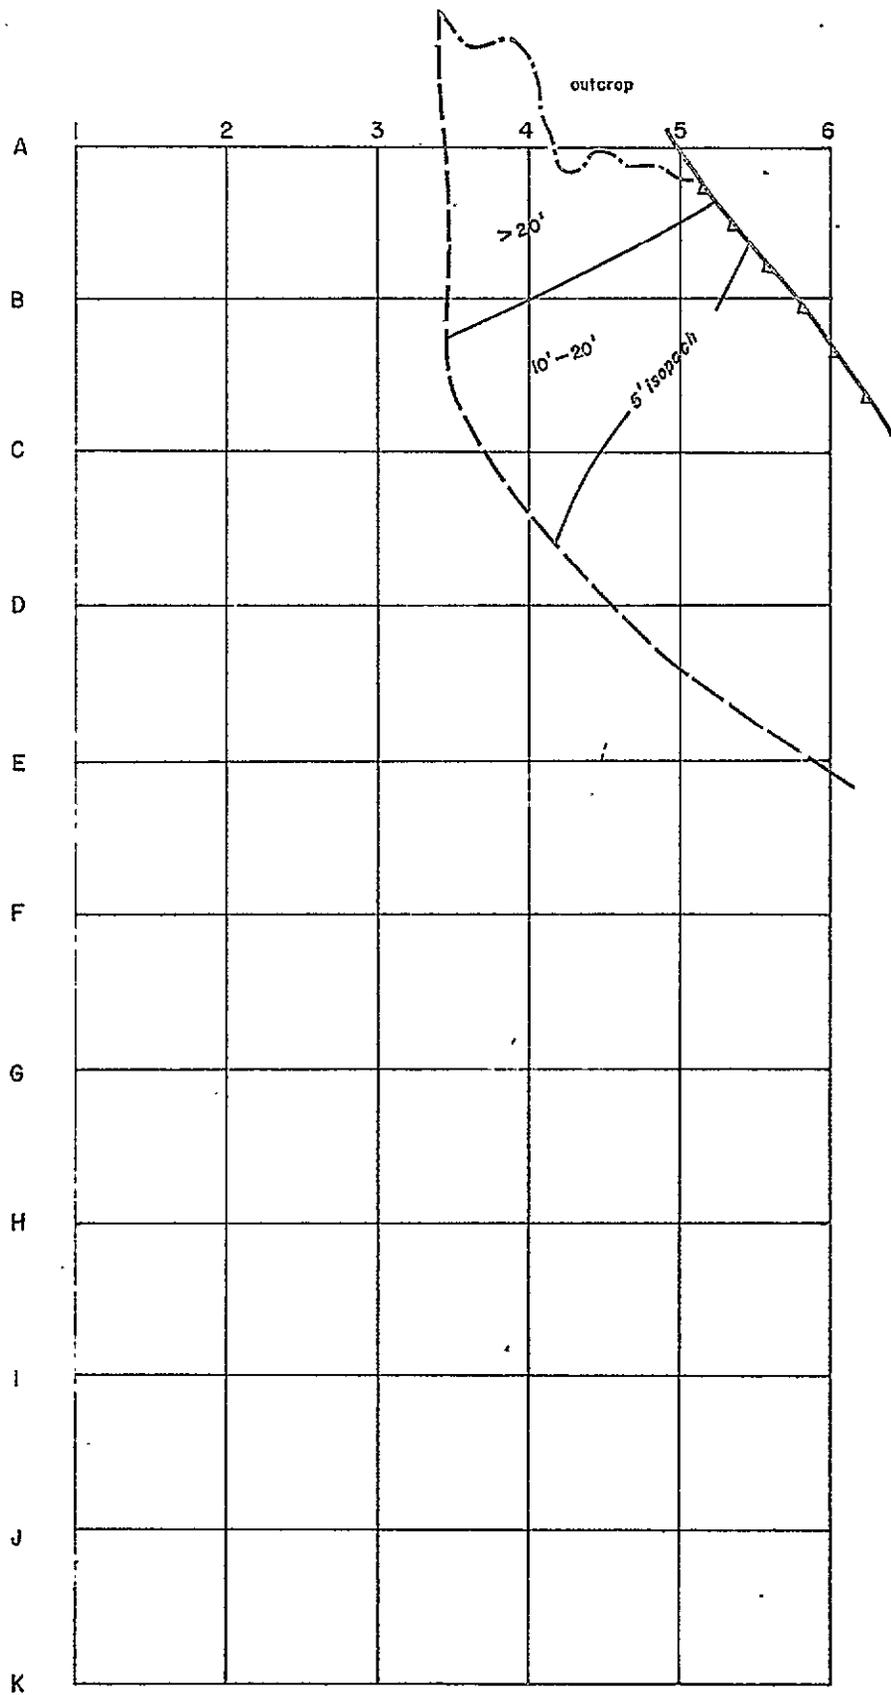
SKETCH ISOPACH MAP
INTERSEAM SEDIMENTS
BETWEEN
CHAMBERLAIN & SKEETER SEAMS
PLATE 3
