SUKUNKA COAL PROJECT

GEOLOGICAL REPORT ON THE
STRIP MINE POTENTIAL OF THE
NORTHERN PART OF PLATE 1

PREPARED FOR: COALITION MINING LIMITED

BY: CLIFFORD McELROY & ASSOCIATES PTY. LIMITED

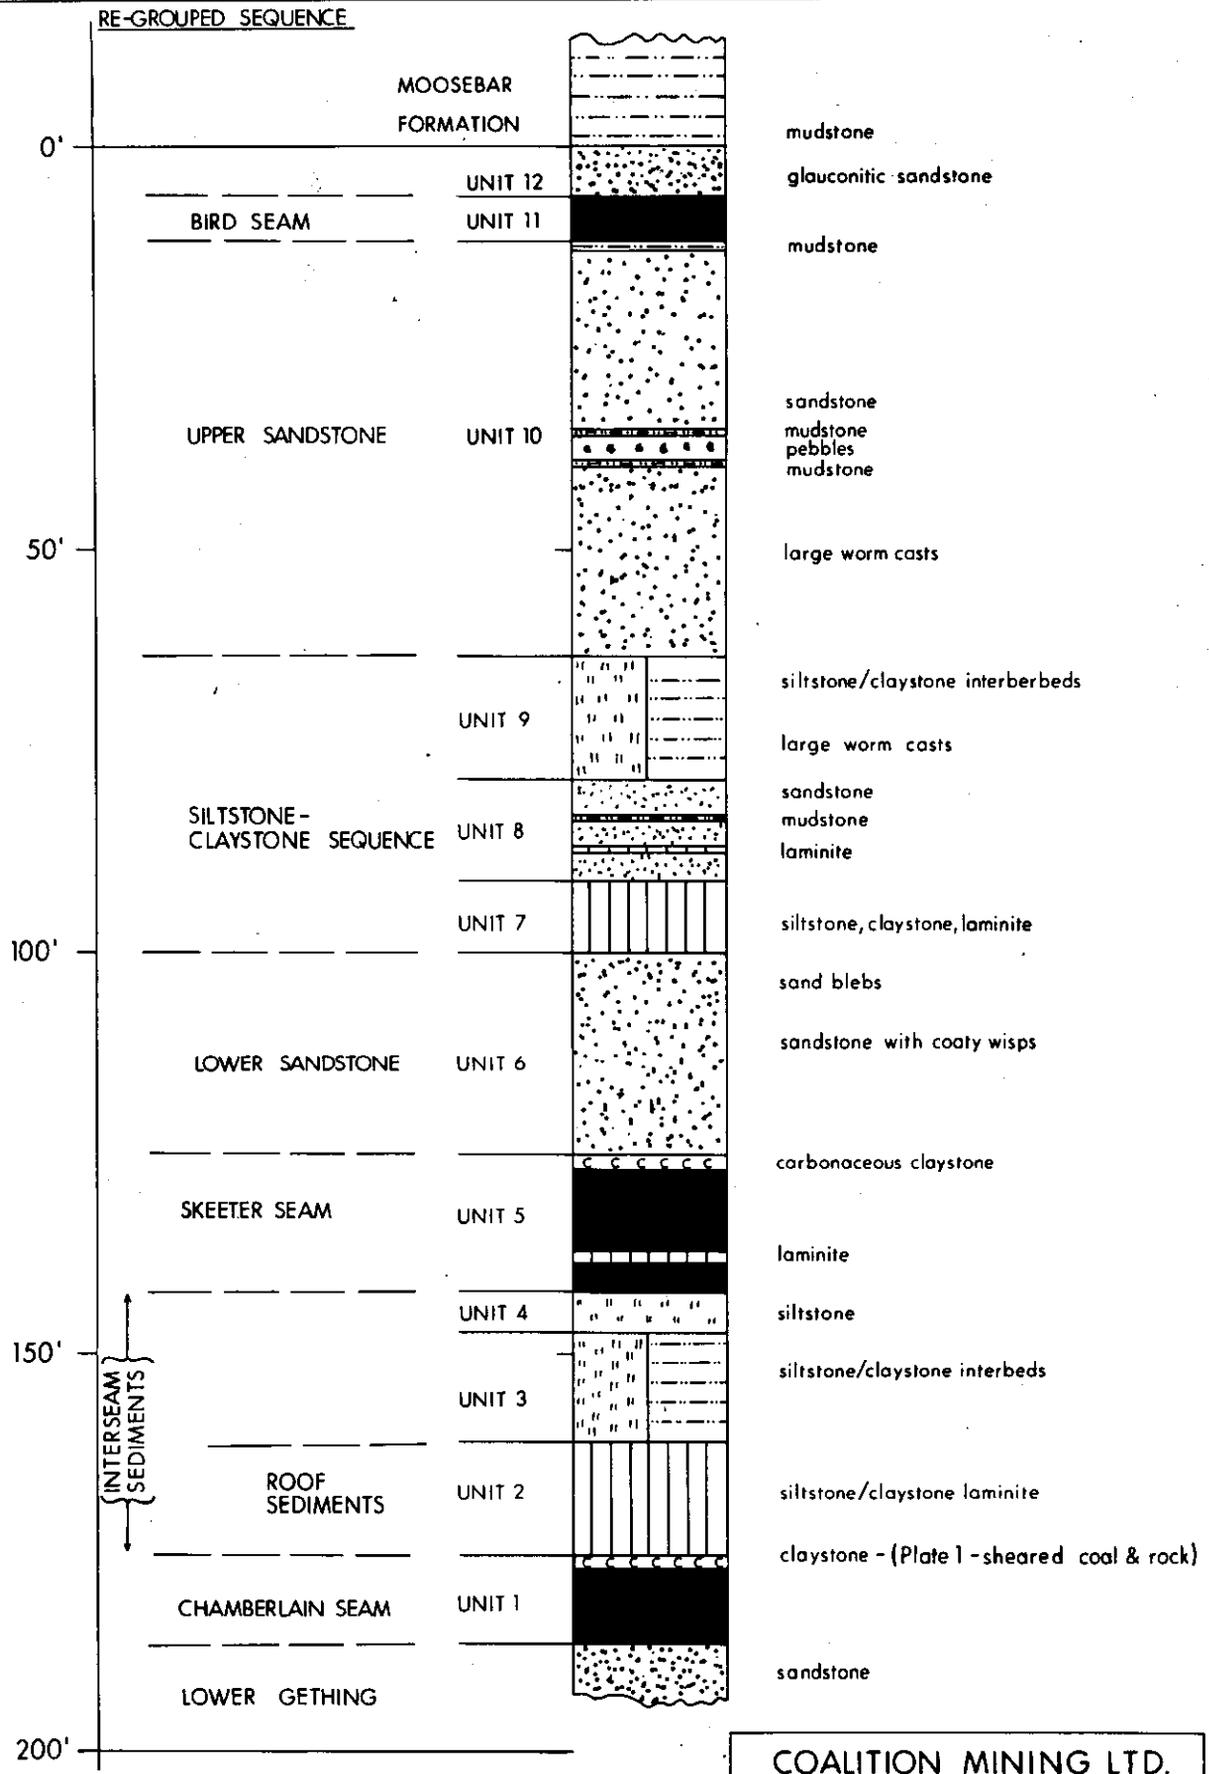
See the 1972 GEOLOGICAL REPORT for detailed descriptions of UNITS 1 to 12.

This sequence comprises Units 7, 8, and 9 of the Upper Gething sequence; see Figure 4.1. A relatively constant thickness variation of between 28.4 feet (D.D.H. Pl-24) and 32.8 feet (R.D.H. Pl-4A) is observed throughout the area where a complete interval is intersected. Interbedded siltstone and claystone is the dominant lithology of this sequence. In detail, a lower siltstone/claystone laminitic is separated from an upper unit of interbeds by a fine-grained sandstone interval, which contains silty phases. Detailed descriptions are included in Section 4.3 of the 1972 Report.

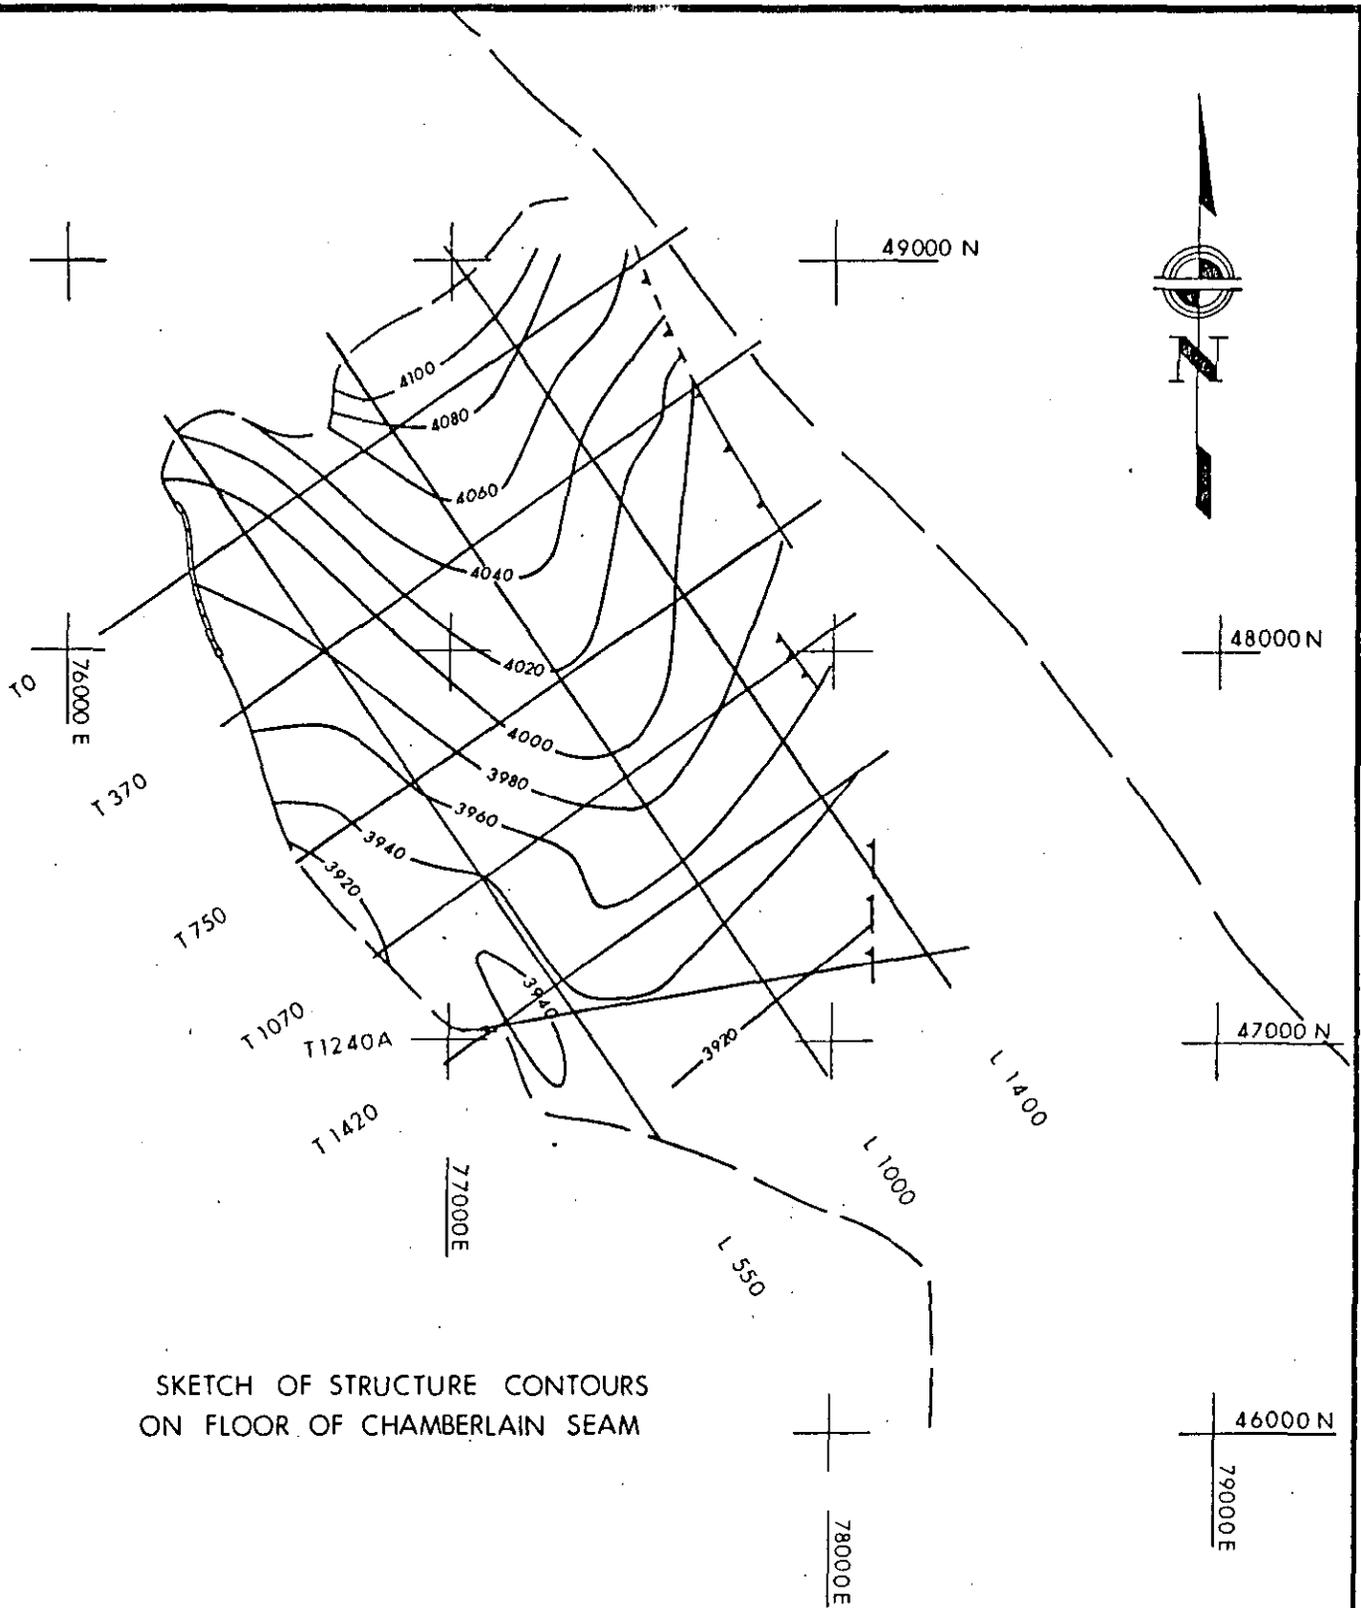
FIGURE 4.2

SKETCH OF STRUCTURE CONTOURS
ON FLOOR OF CHAMBERLAIN SEAM

See also Map 3 for details of
contours at scale 1" = 100 feet.

The internal structure of the Plate is a south-easterly plunging anticline. The structural entities of Plate 1 are illustrated on the Structure Contour Maps on the Floors of the Chamberlain and the Skeeter Seams, Maps 3 and 4, respectively; for convenience these maps are reproduced as Text Figures 4.2 and 4.3, respectively. Note that the eastern limit of the plate at the level of the two seams varies with the intersection of the respective seam against the Chamberlain Fault or with respect to the strip mine area, the subsidiary faults.

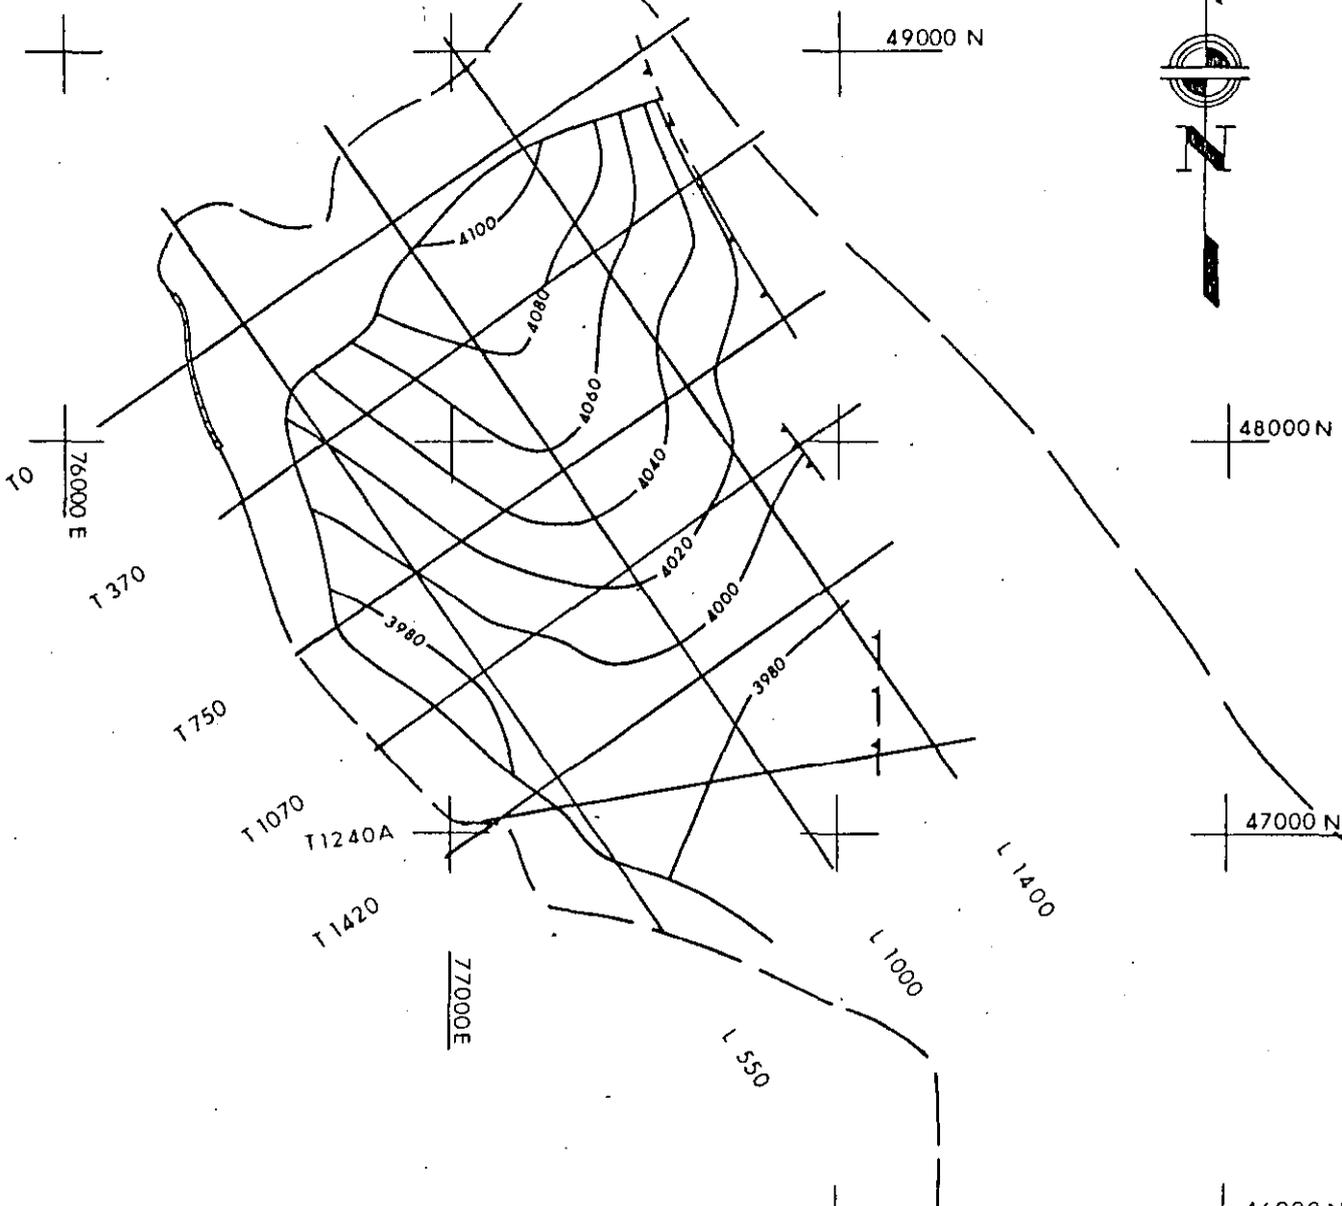
SKETCH OF STRUCTURE CONTOURS
ON FLOOR OF SKEETER SEAM

See also Map 4 for details of
contours at scale 1" = 100 feet.
Contour Interval: 20 Feet

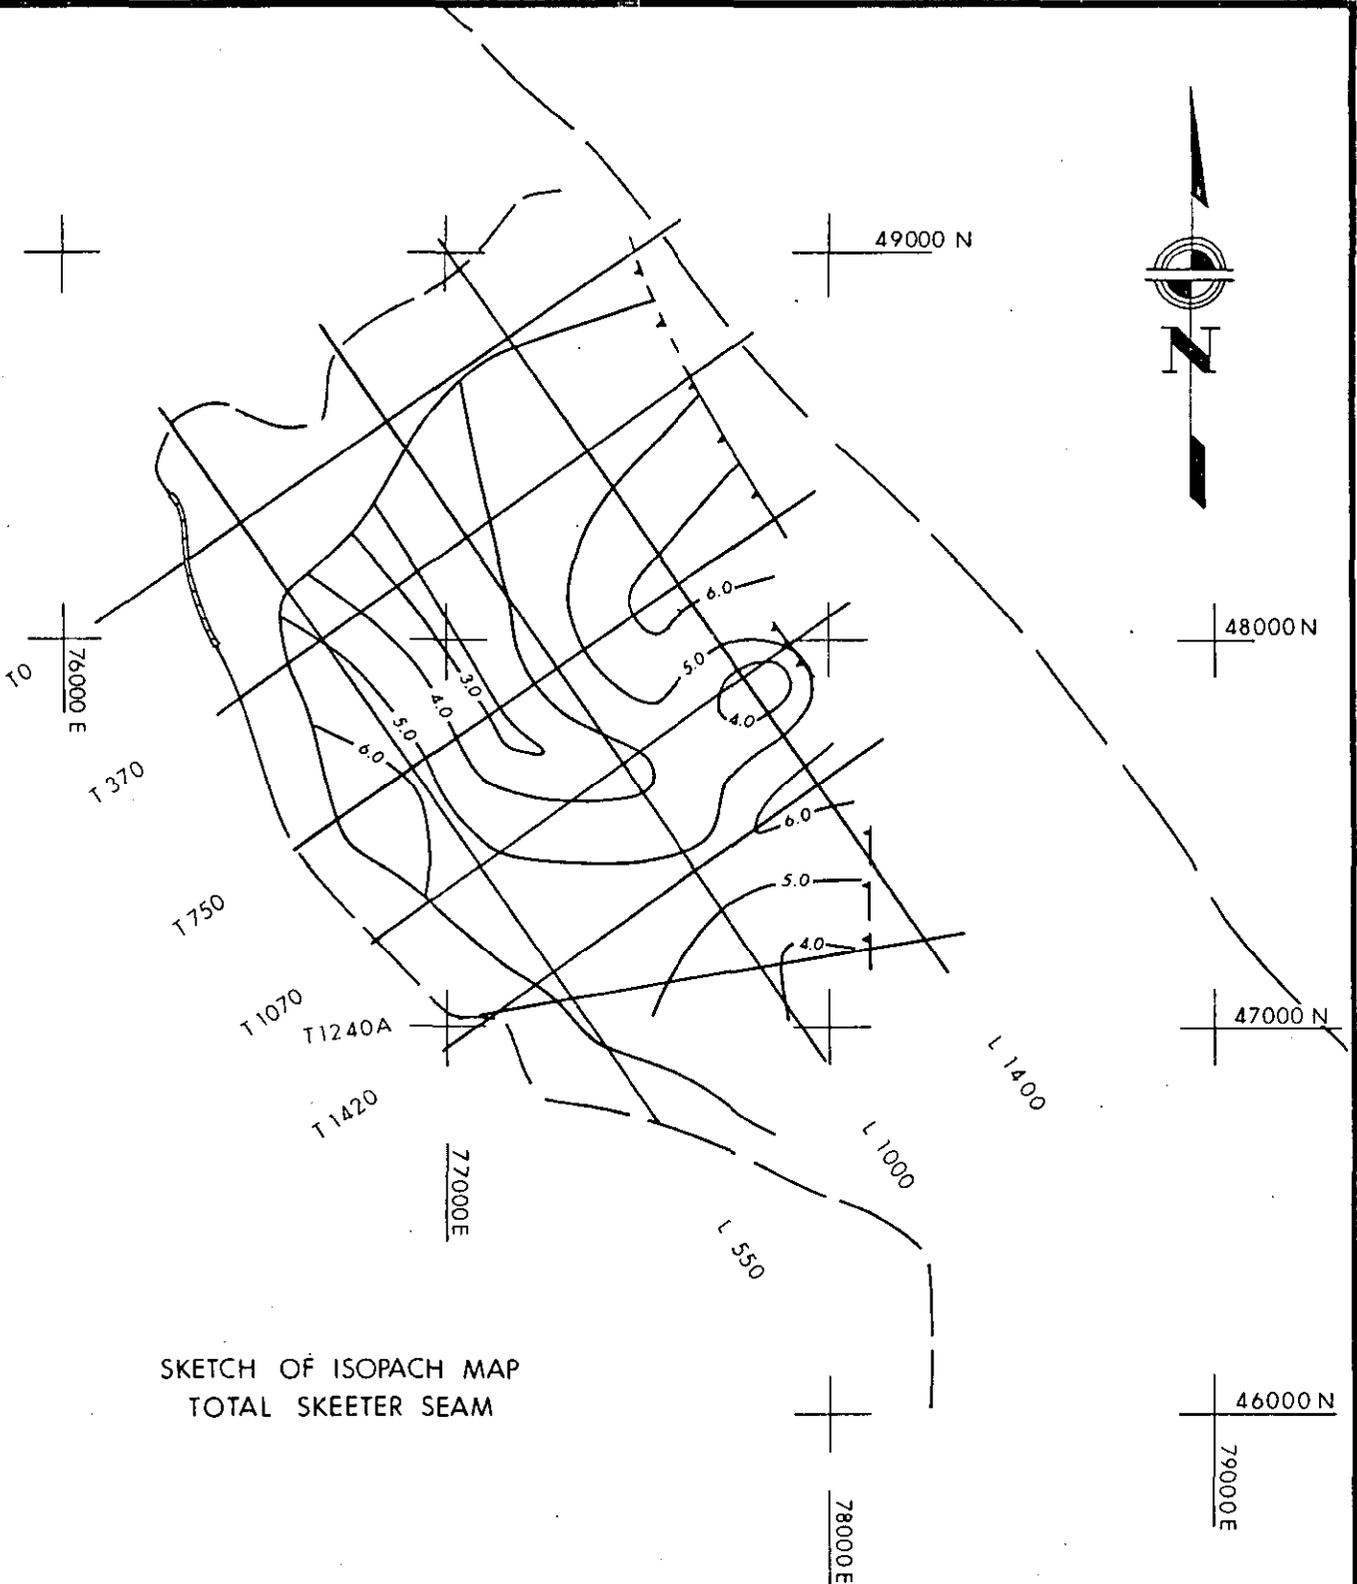
| FIGURE 5.1 |

SKETCH OF ISOPACH MAP
TOTAL SKEETER SEAM

See also Map 6 for details of
contours at scale 1" = 100 feet.

The overall character of the Skeeter Seam has been discussed in Section 4.2.2 (iii), above. The Isopach Map of the seam thickness, Map 6 (see also Figure 5.1) shows the seam varying in thickness between 3.0 feet and 6.6 feet. The average seam thickness, based on the bore hole intersections is 4.73 feet.

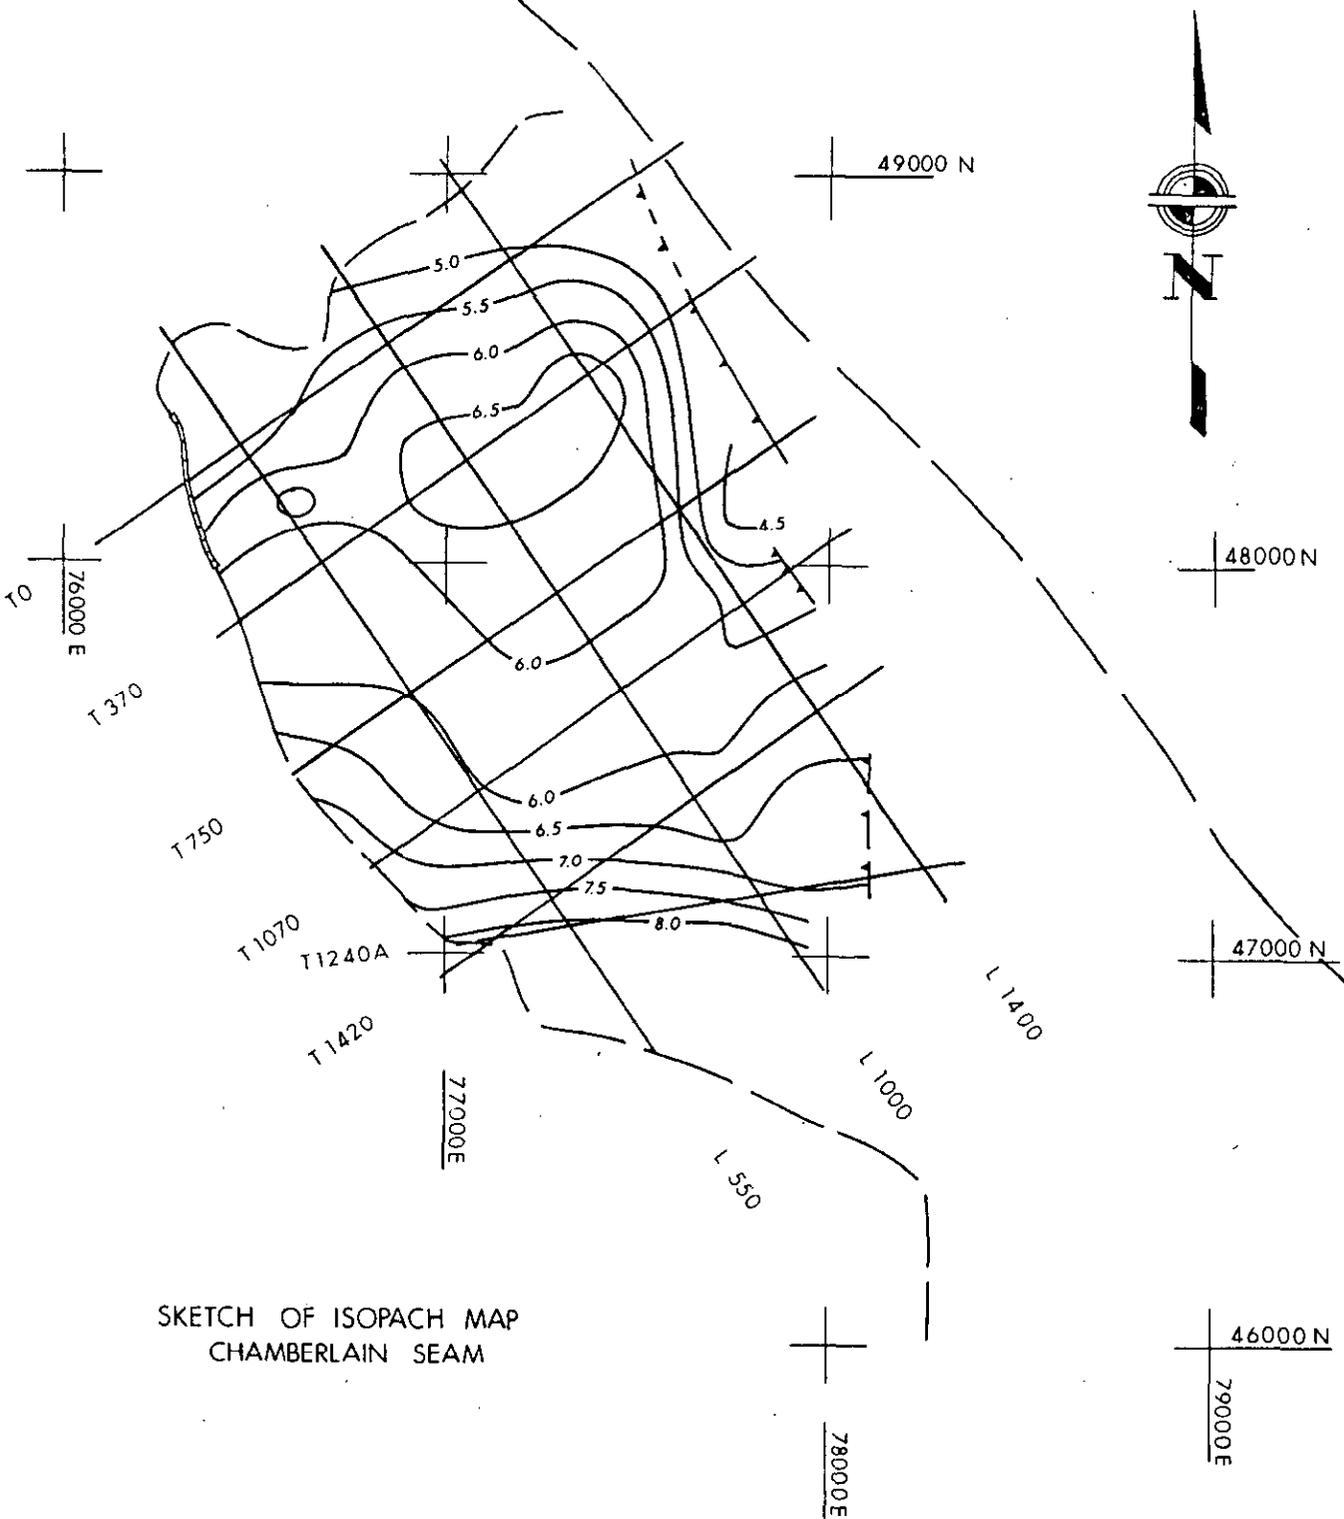
SKETCH OF ISOPACH MAP
CHAMBERLAIN SEAM

See also Map 5 for details of
contours at scale 1" = 100 feet.
